ASCE 31 SEISMIC ASSESSMENT 100 N MAIN STREET MEMPHIS, TENNESSEE

October 2, 2013

**ASCE 31 SEISMIC ASSESSMENT
100 NORTH MAIN STREET
MEMPHIS, TN**

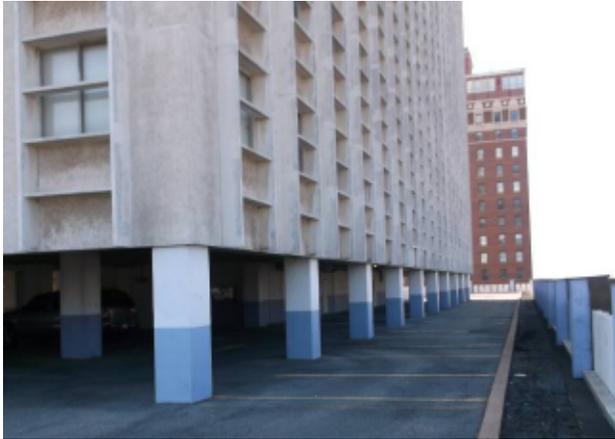
Base of Tower at 8th Level Roof

- Adjacent Buildings: The 1" expansion joint between the 8-story garage and the tower is not large enough to accommodate expected deflections.
- Geometry: The tower is set back on 3 sides from the edge of the garage podium, resulting in a large vertical irregularity.

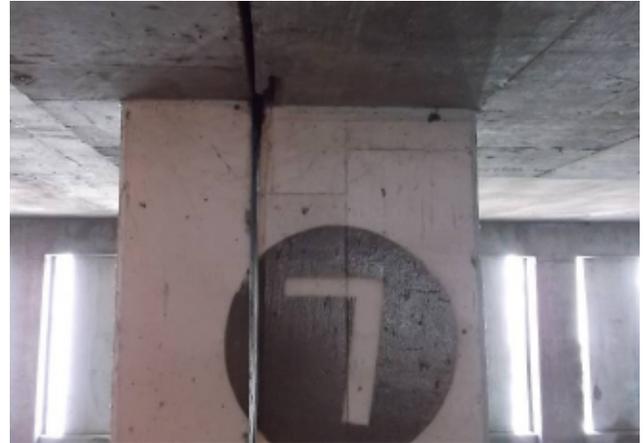
1" Expansion Joint

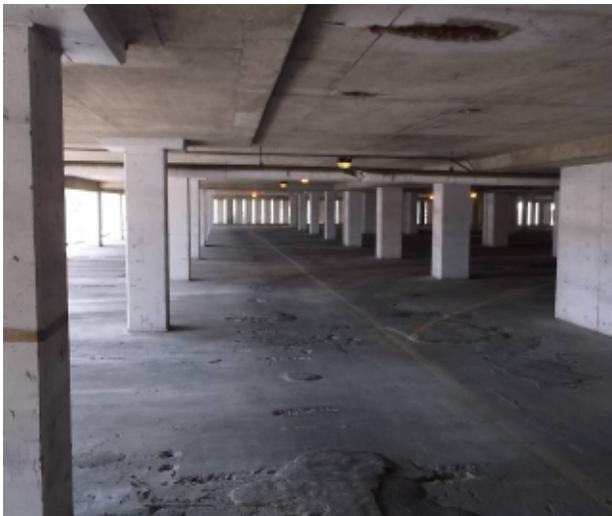
Typical Parking Level

- Deterioration of Concrete: The garage sections display excessive concrete deterioration.
- Shear Stress (Shear Walls): The shear stresses in the concrete shear walls, calculated using the Quick Check procedure, exceeds allowable stresses at the 24th level where the number of walls is reduced.

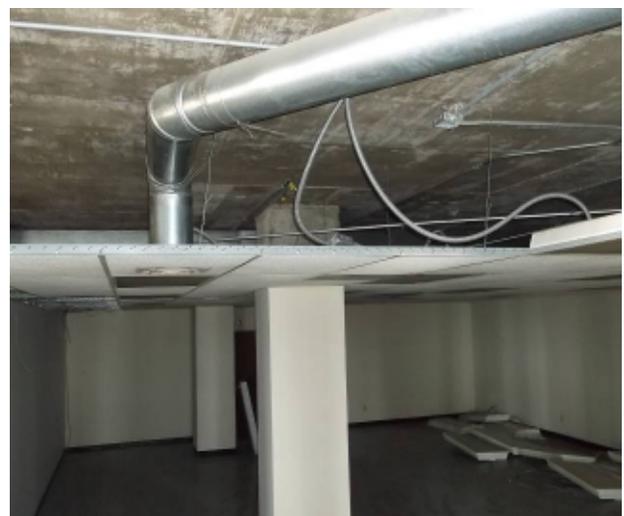
Typical Flat Slab at Interior Column

- Flat Slab Frames: 8" flat slab framing into concrete columns is prone to punching shear failure.
- Column Bar Splices: The slices of the smaller column reinforcing bars are too short.
