STRUCTURAL ENGINEERING ASSESSMENT REPORT

80-88 North Main Street, Memphis, Tennessee

Prepared for
Downtown Memphis Commission
Mr. Brett Roler

Job No. 2021105

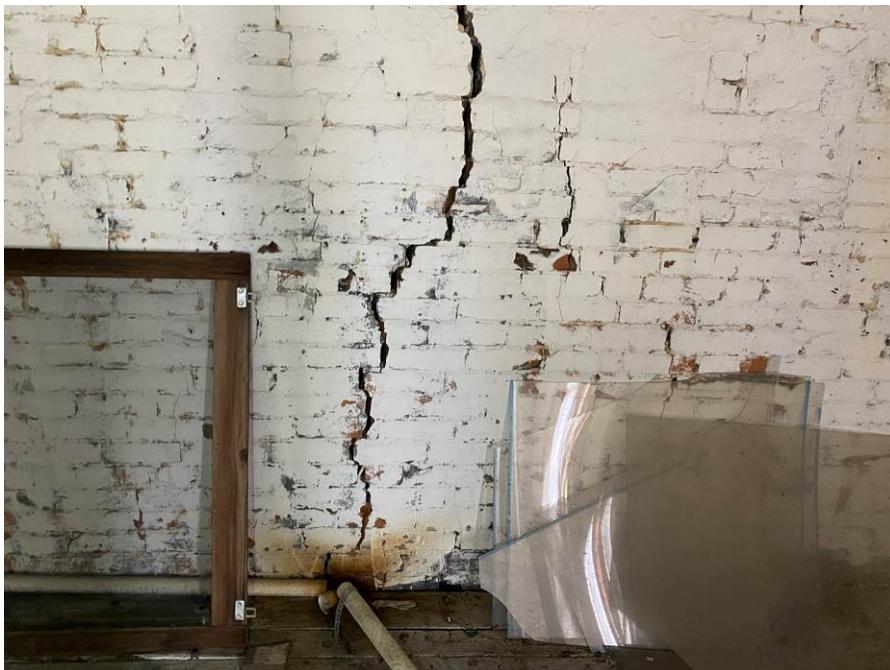
approximately an inch in magnitude and were located on the ground floor and the second story northern exterior wall. The cracks were generally vertical in orientation and traveled through both the brick and the mortar. The cracking had the appearance of aged cracking and did not appear active; however, we recommend that the cracks be repaired to prevent additional separation of the masonry materials. There does appear to be impact damage from the exterior of the building located adjacent to the parking lot on the north side of the building. We recommend tuck pointing the exterior cracks to prevent water infiltration into the building and to prevent additional movement of the bearing wall (Photos 41 through 48)

Photo 42 Magnitude of Masonry Crack on 88 North Main

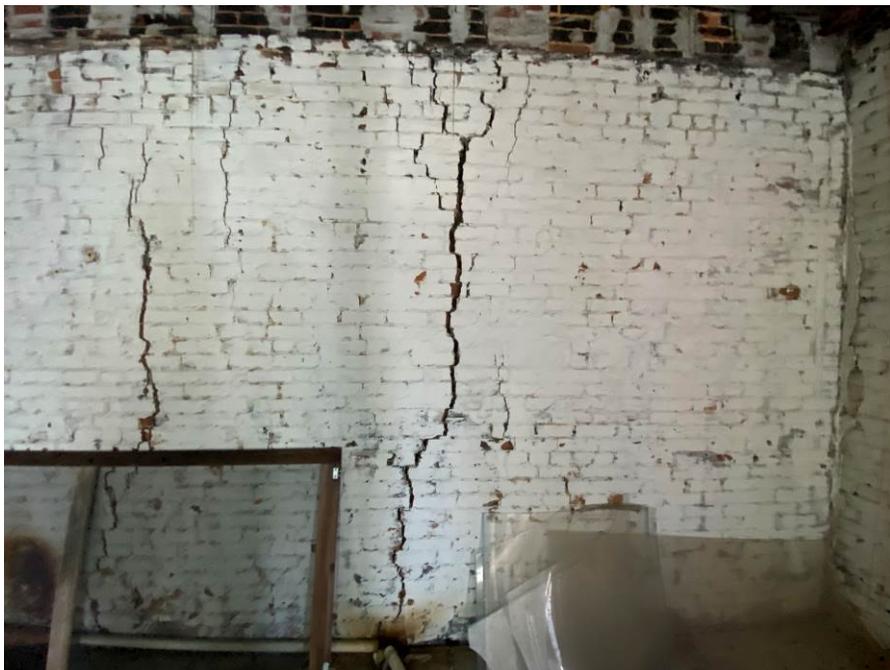
Photo 44 Exterior Wall Cracks on 88 North Main

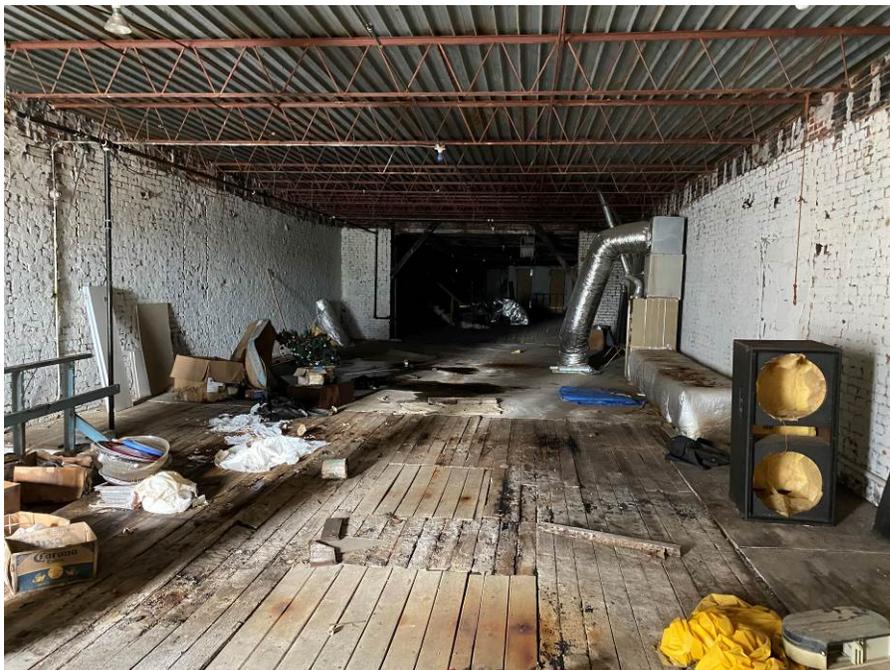
Photo 46 Second Floor Metal Deck and Steel Bar Joists Framing on 88 North Main

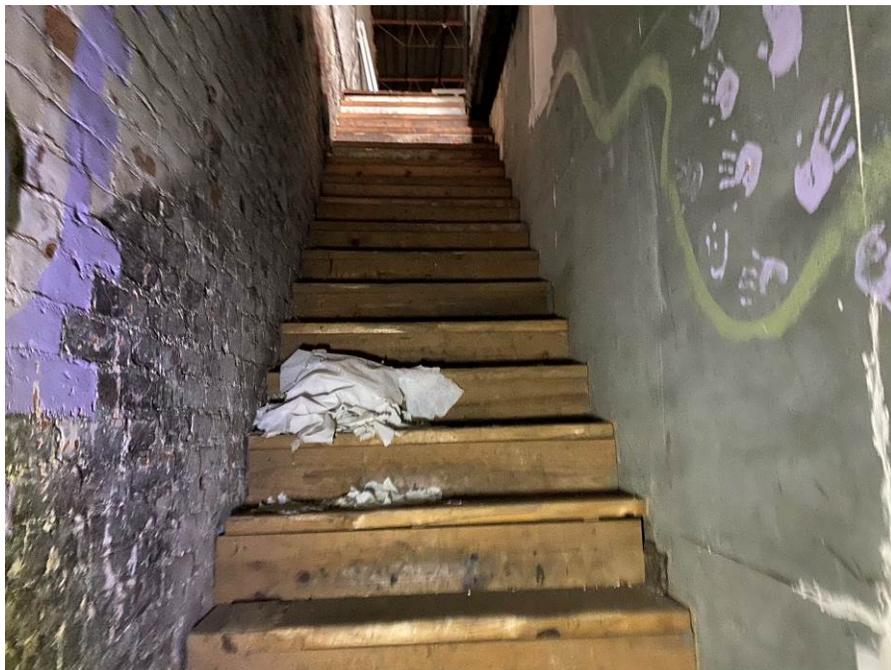
- The basement stairs in the 88 North Main building shall be shored prior to any access due to poor framing conditions and deterioration of the wood framing members. Additionally, there is a lack of an adequate handrailing in this location. (Photos 59 through 62)

Photo 52 Stair Condition in 88 North Main (Shoring Recommend)

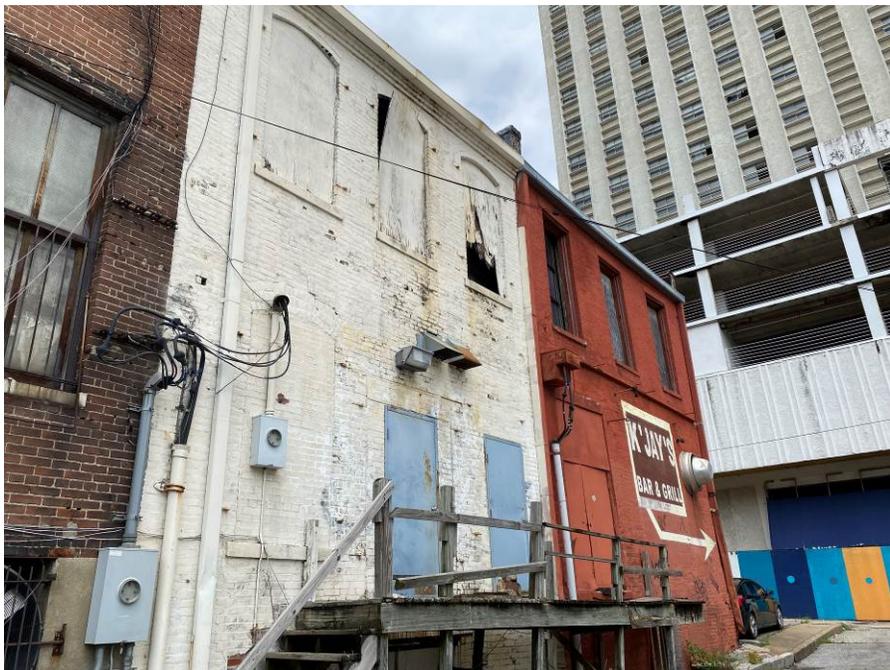
- Several of the building's windows have deteriorated or been broken over the many years of neglect and exposed the interior framing to natural elements. The majority of the open windows are located on the November 6th street side of the building. Several of the framing members on the rear of the buildings were observed to have moisture intrusion damages. The water was entering through both open windows and through the poor conditions of the roof coverings. We recommend these openings be sealed to prevent additional moisture entry into the building. Additionally, the deteriorated framing materials on the rear of the buildings should be sistered or replaced with new framing members. Damages were located in the 88 and 86 North Main buildings at the rear. Repairs to these

Photo 58 Openings at 86 North Main at Windows

locations shall be completed prior to access to the building to the public. (Photos 55 through 58)

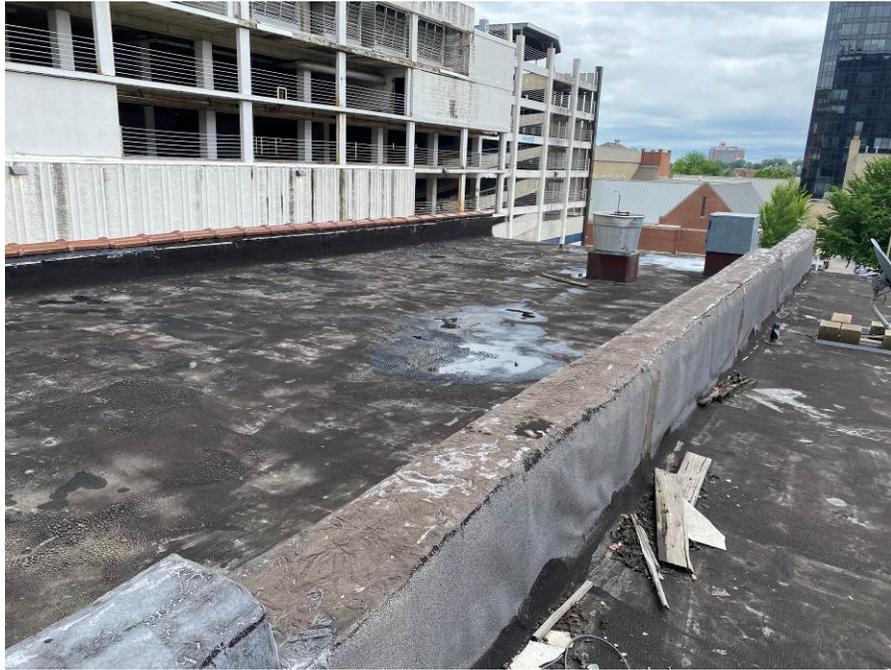
Photo 59 Aged Condition of Roof Coverings

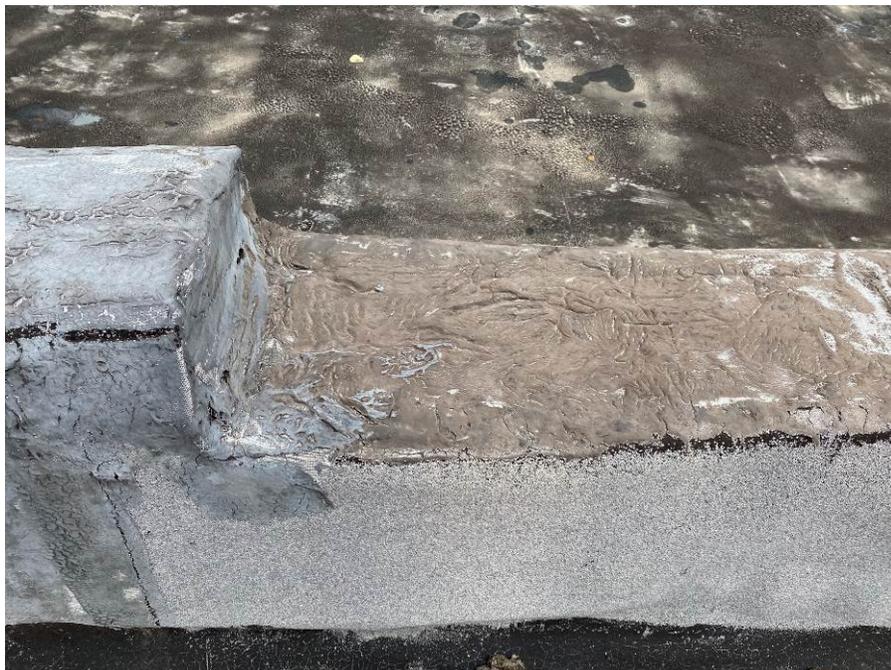
Photo 60 Poor Condition of Wall Flashing Between 88 North Main and 86 North Main

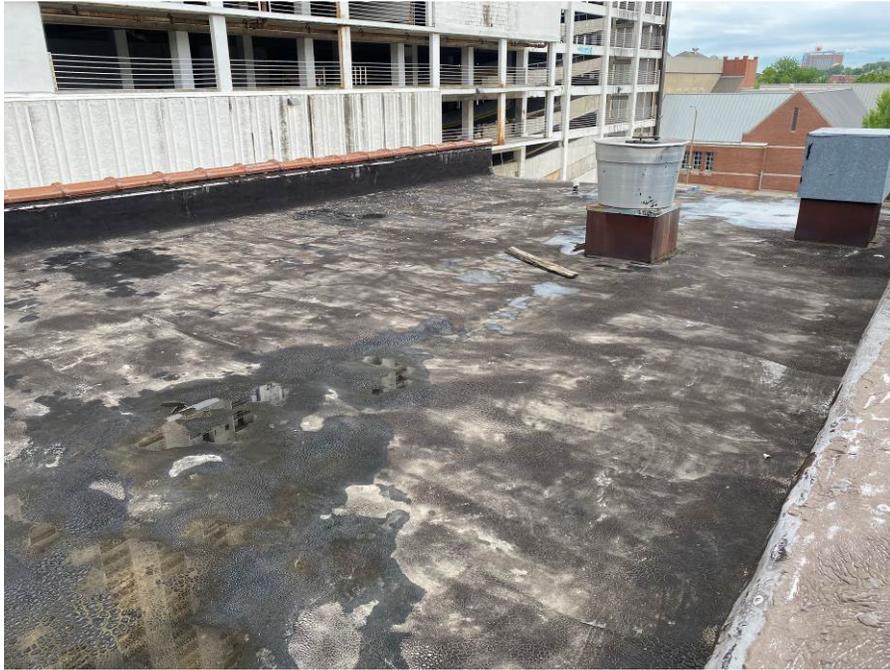
Photo 61 Ponding over 88 North Main

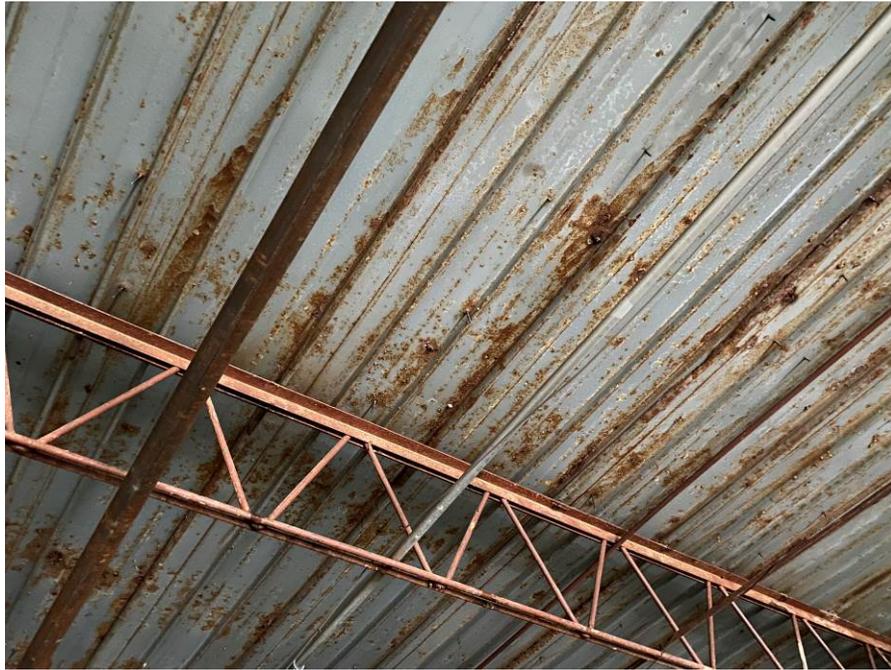
- The metal decking of the addition on 88 North Main was observed to have oxidation damages consistent with long-term water exposure. Damages were observed on the roof and floor levels of the addition. We recommend that repairs be made during improvements; however, the damages are not advanced enough to prevent public access to the building during walkthroughs. (Photos 63 through 66)

Photo 63 Oxidation Damages on Metal Decking

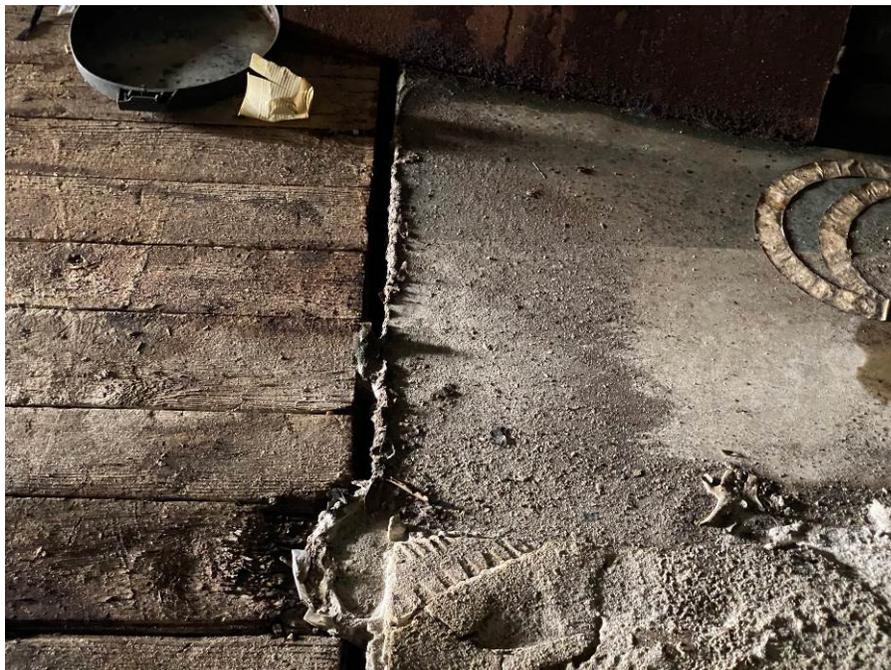
Photo 64 Joint at Concrete and Floor Decking at 88 North Main

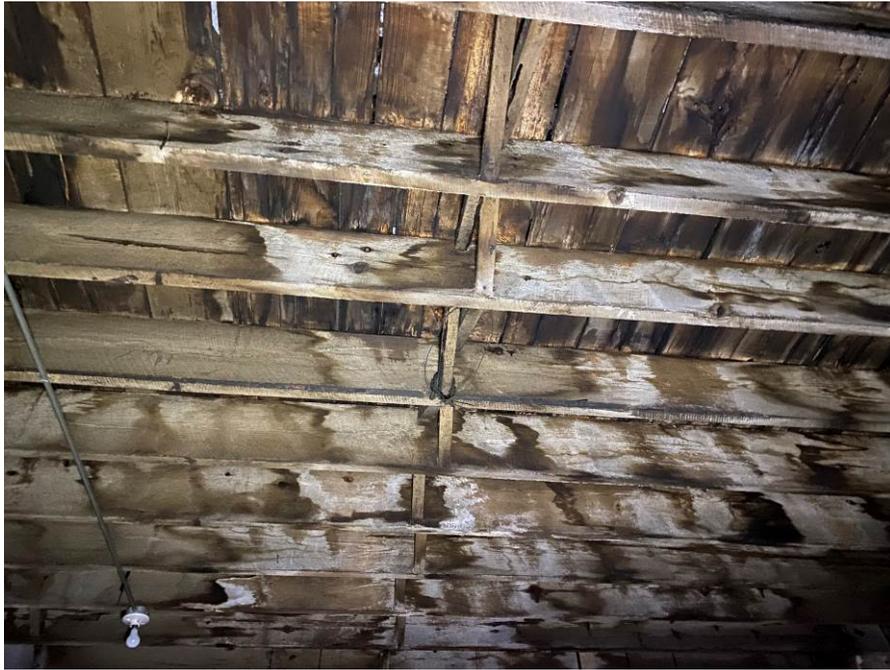
Photo 67 Roof Joists Condition at 88 North Main (Water Staining Damages)

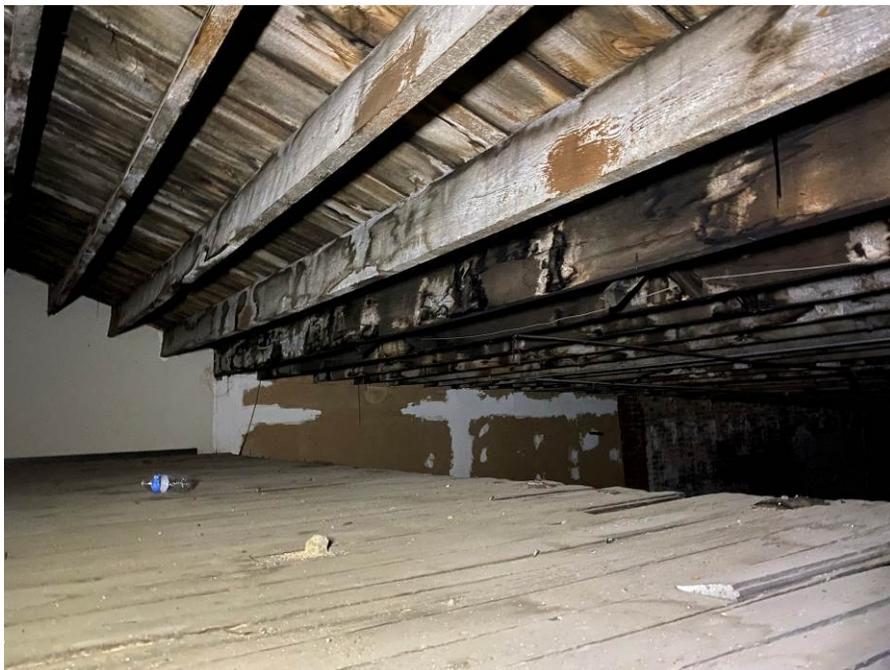
Photo 68 Condition of Roof Joists at 88 North Main Four Story Area

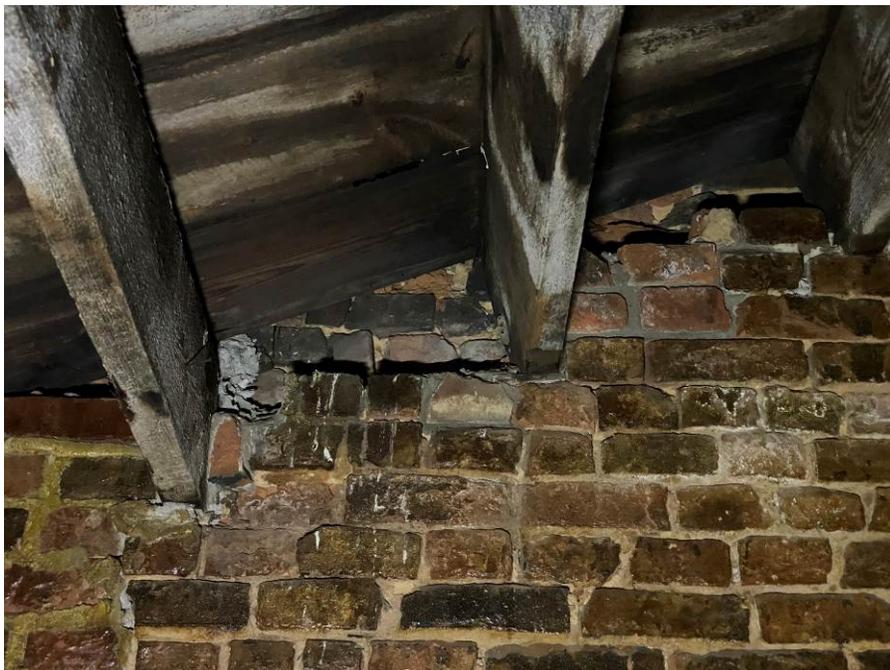
- On the fourth-floor portion of the 88 North Main building, we noted that the roof joists were sloped aggressively and several joists were torqued. We recommend that the joists be blocked and repaired to prevent movement at the roof. In general, the roof framing members were in good condition with only spot repairs necessary. (Photos 67 through 72)

Photo 70 Rotating Joists at Sloped Area on 88 North Main

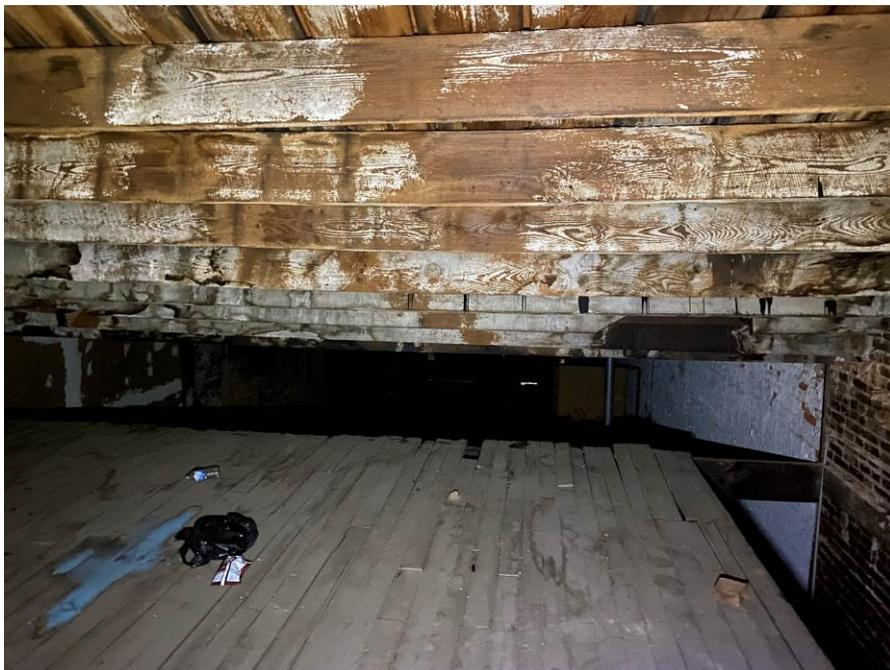
Photo 72 General Condition of Roof Framing at 88 North Main

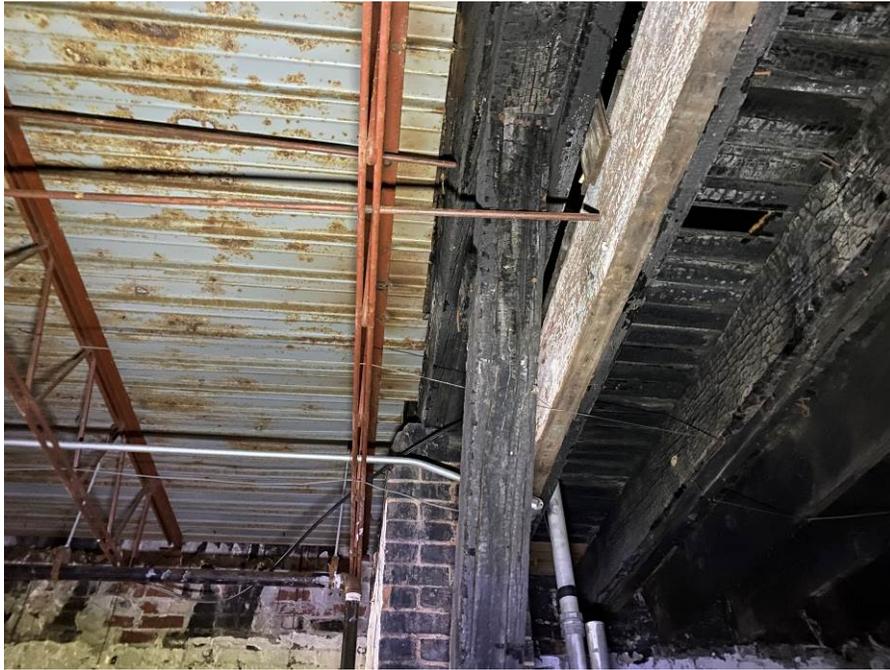
- Several joists and decking members were observed as having past charring from a fire at the joint between the addition and the existing building of 88 North Main. We recommend that the charred joists, beam, decking and kickers be removed and replaced or sistered. (Photos 73 through 76)

Photo 73 Charred Framing at 88 North Main to be Repaired

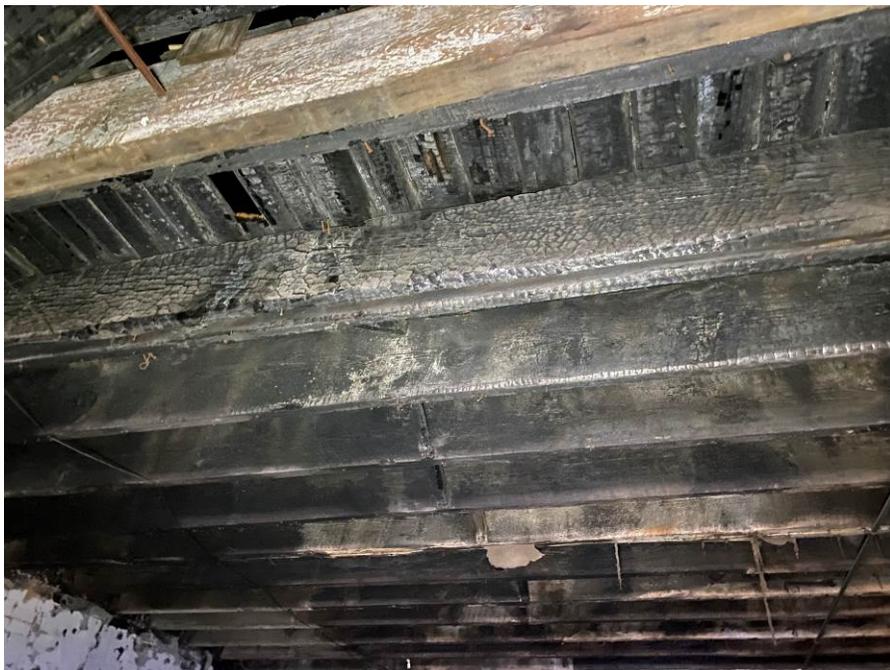
Photo 74 Charred Joists at 88 North Main to be Repaired

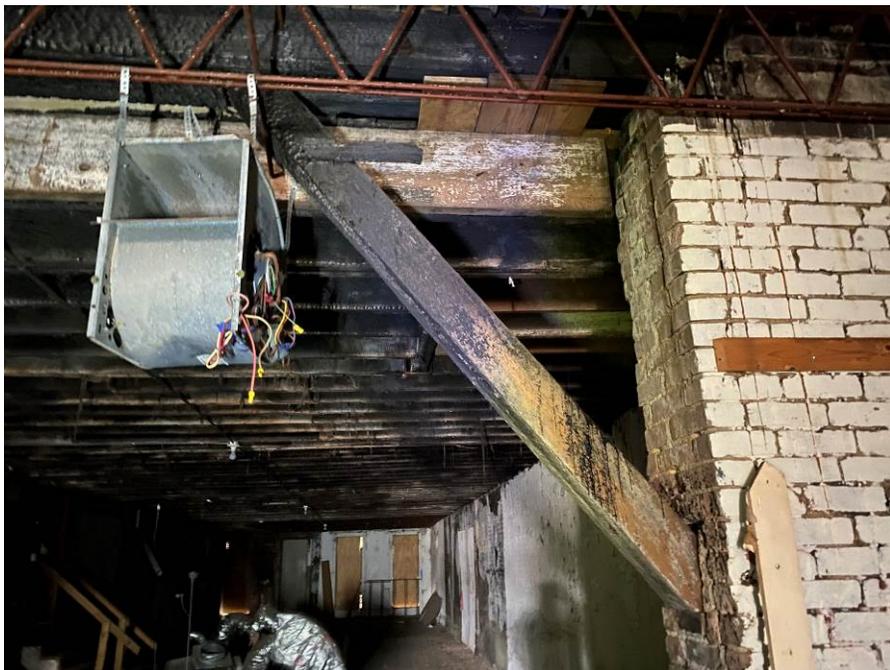
Photo 76 Charred Kicker to be Replaced at 88 North Main

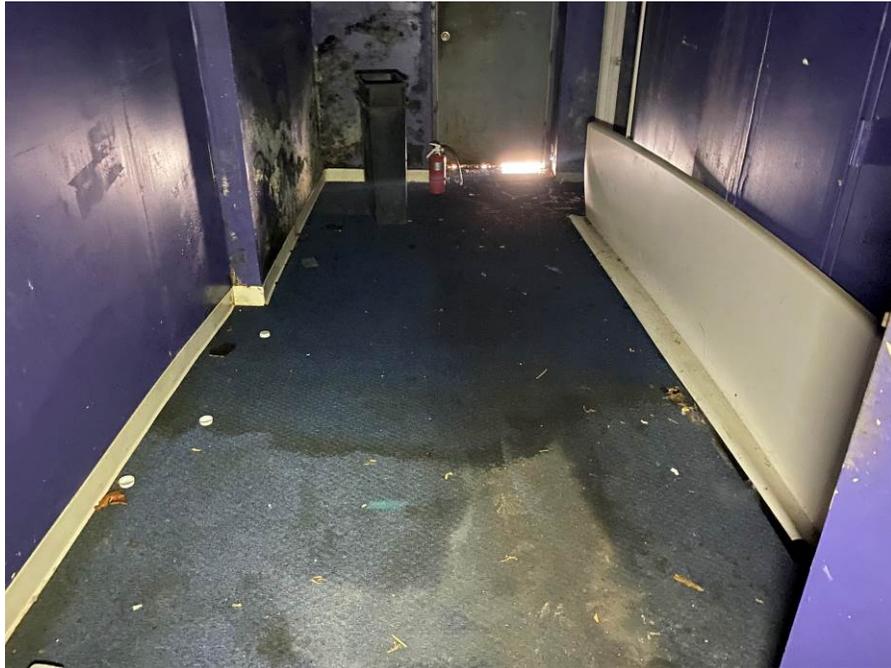
- Water entry has been occurring on 86 North Main at the rear entry. We noted water damages caused by roof covering openings that have damaged the wood framing at the rear of the building. The 1x wood decking had stains consistent with long term water exposure. We recommend removal and replacement of the damaged decking and sistering of the deteriorated wood joists at the rear of the building. (Photos 77 through 88)

Photo 77 Saturated Floor Framing on 86 North Main

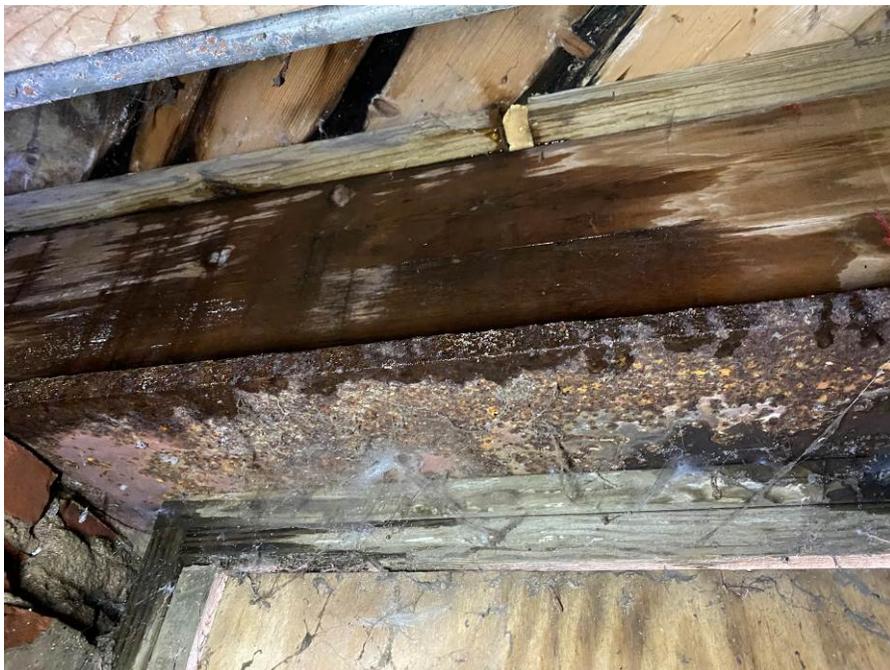
Photo 82 Active Moisture Leak at Framing at 86 North Main

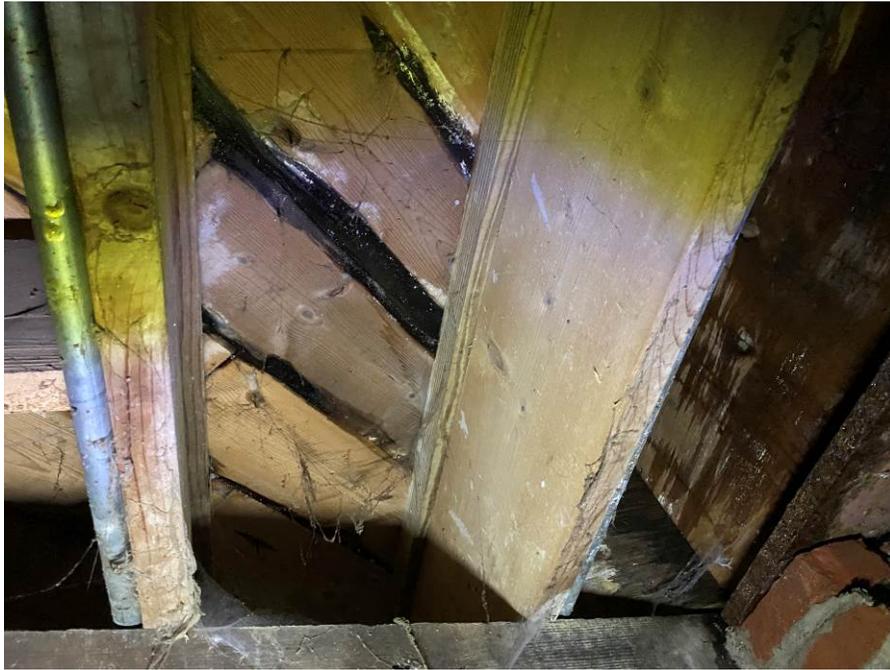
Photo 83 Moisture Damage to Decking at 86 North Main Rear

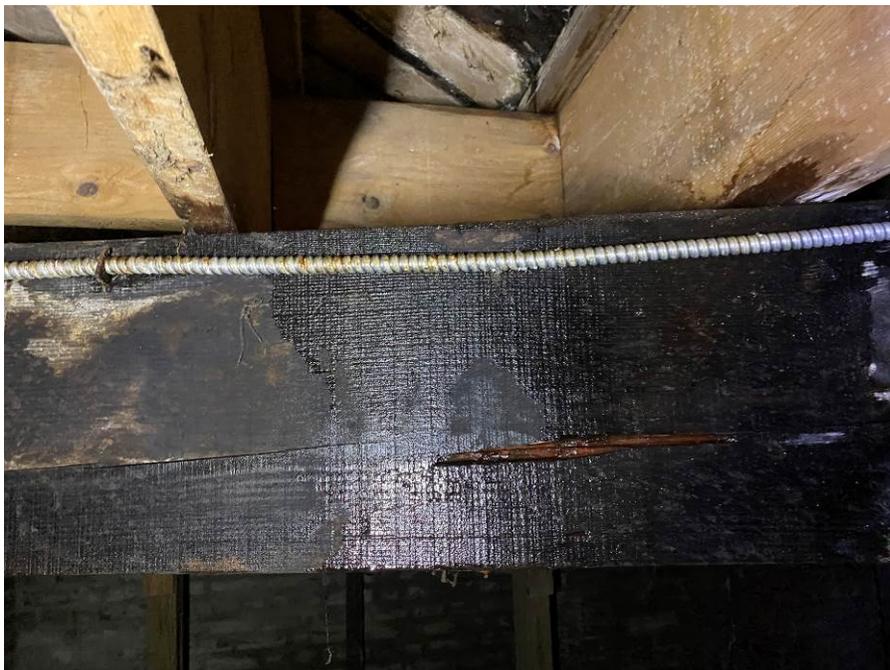
Photo 84 Active Moisture Damages to Rear Framing at 86 North Main

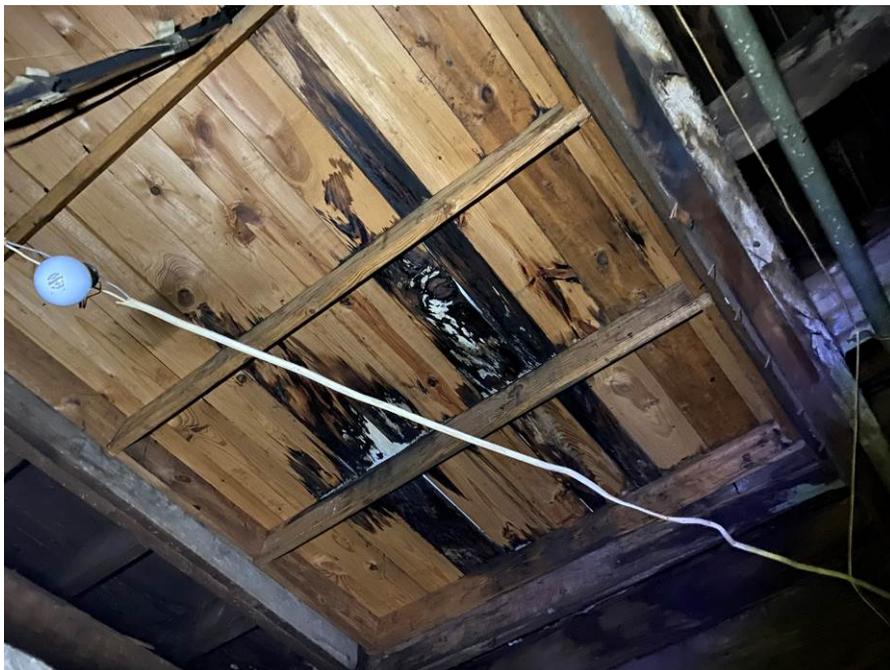
Photo 86 Moisture Damages on 86 North Main Decking (To be Replaced)

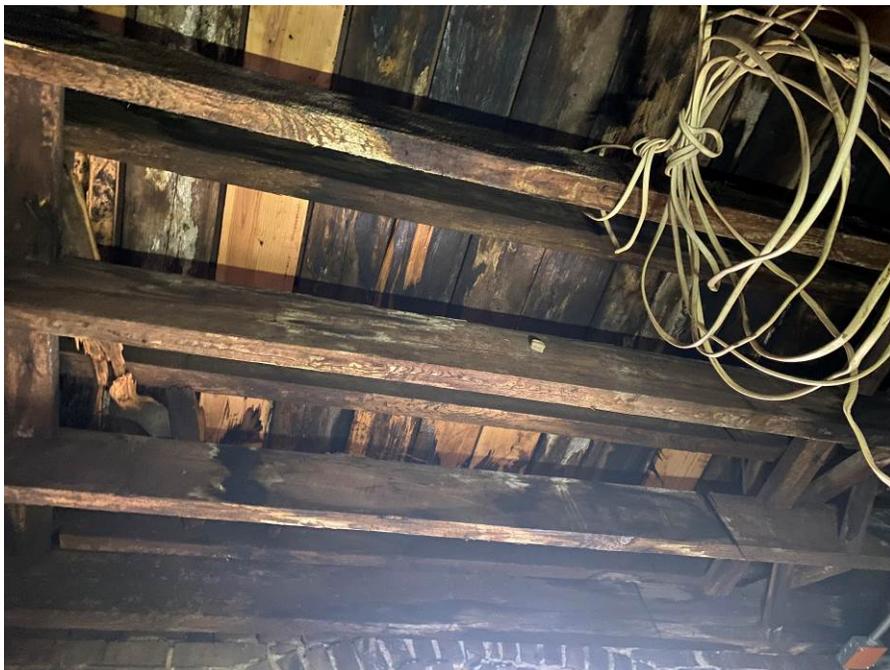
Photo 88 Moisture Damages to Decking at 86 North Main

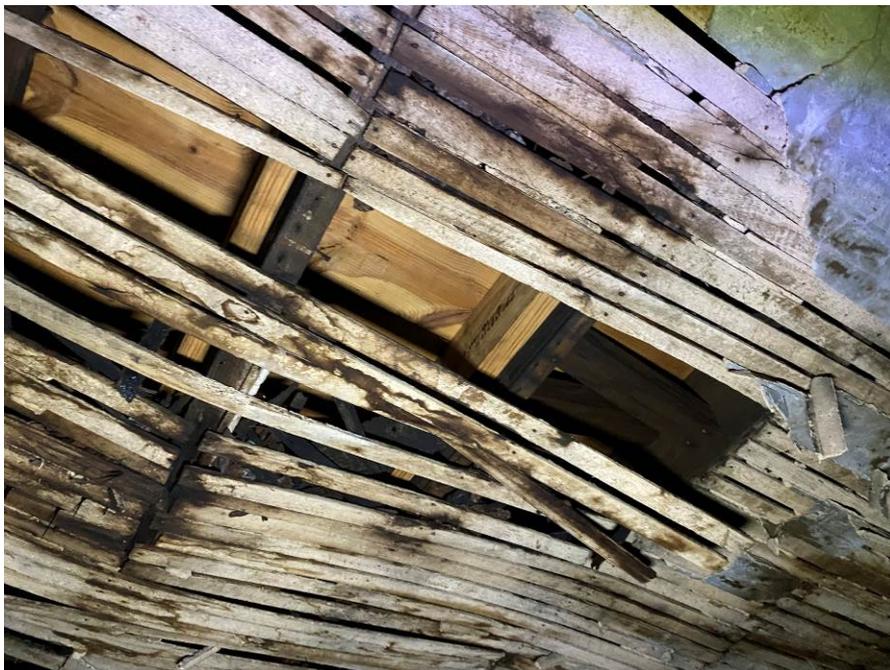
Photo 90 Lath Ceiling Moisture Damage at 86 North Main

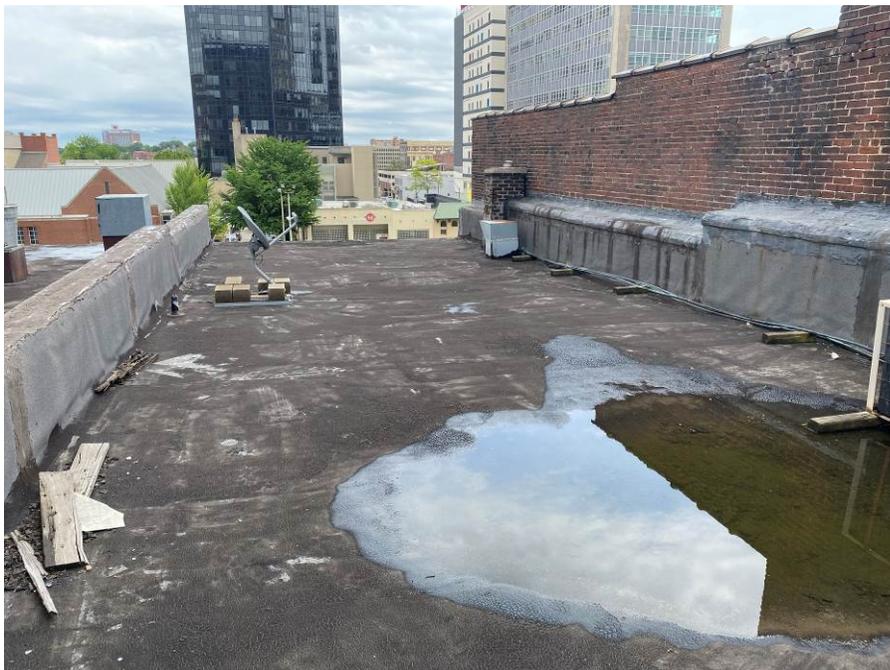
Photo 92 Roof Ponding at 86 North Main

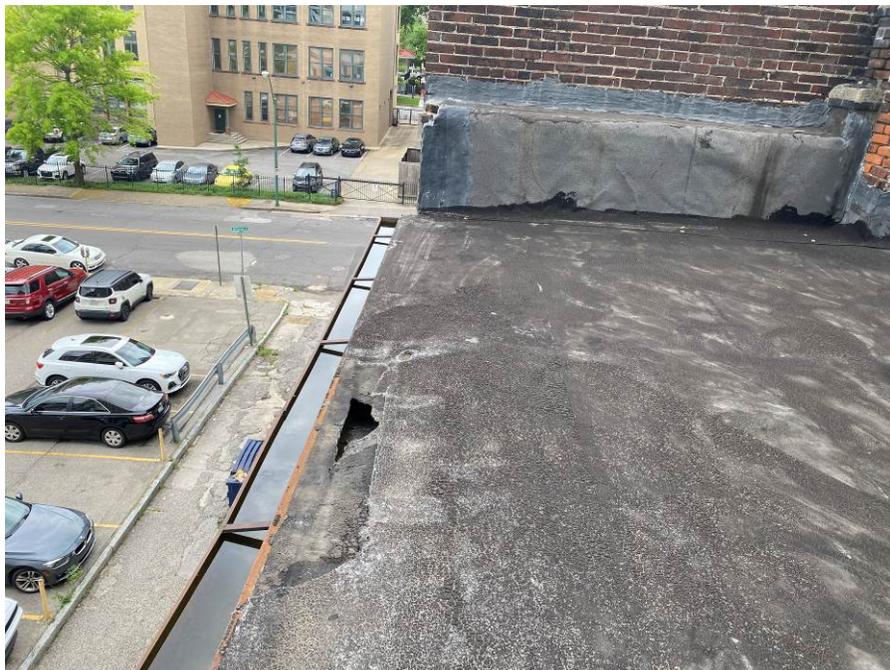
Photo 94 Gutters Full and Hole in Roof Coverings at 86 North Main

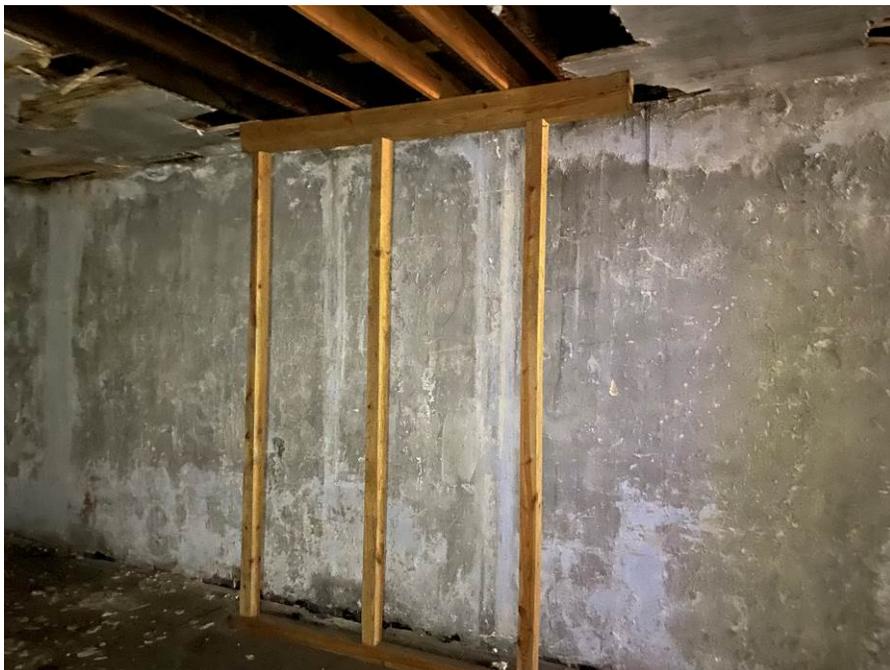
- We observed four (4) roof joists on 86 North Main that were deflecting and had failed. There was temporary shoring in place; however, the shoring was poorly installed and should be strengthened to prevent additional deflection of the roof joists. We observed ponding over the roof coverings on the 86 North Main building that we contributing to the deflection of the roof members. We recommend the upper part of the roof not be accessed by the public until the deflecting joists be repaired. The current repairs do not adequately bear at the masonry walls. The new joists will need to bear at the masonry bearing walls on each side of the building. (Photos 89 through 100)

Photo 98 Condition of Temporary Shoring at 86 North Main

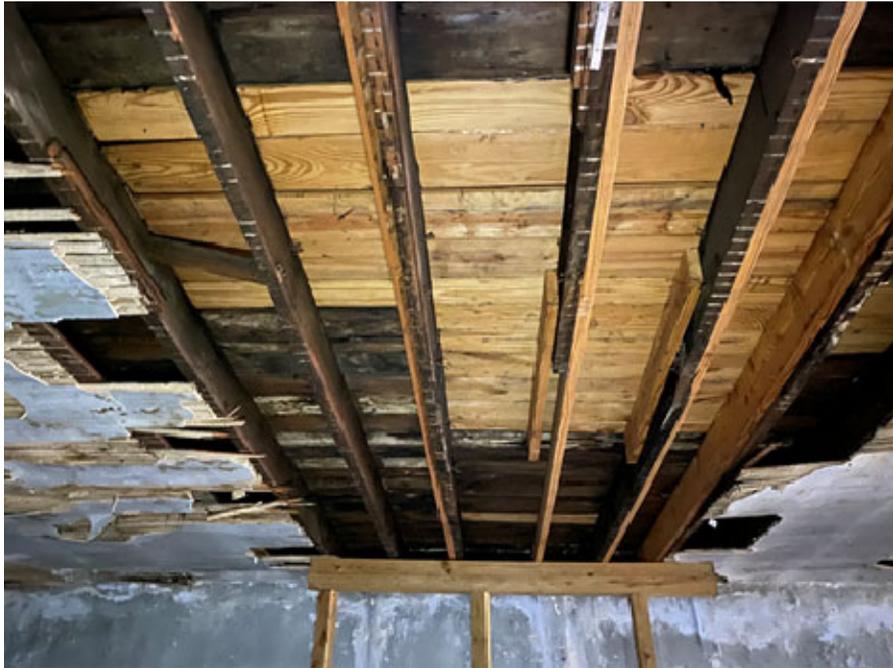
Photo 99 Shoring Condition at 86 North Main Roof (Repairs Required)

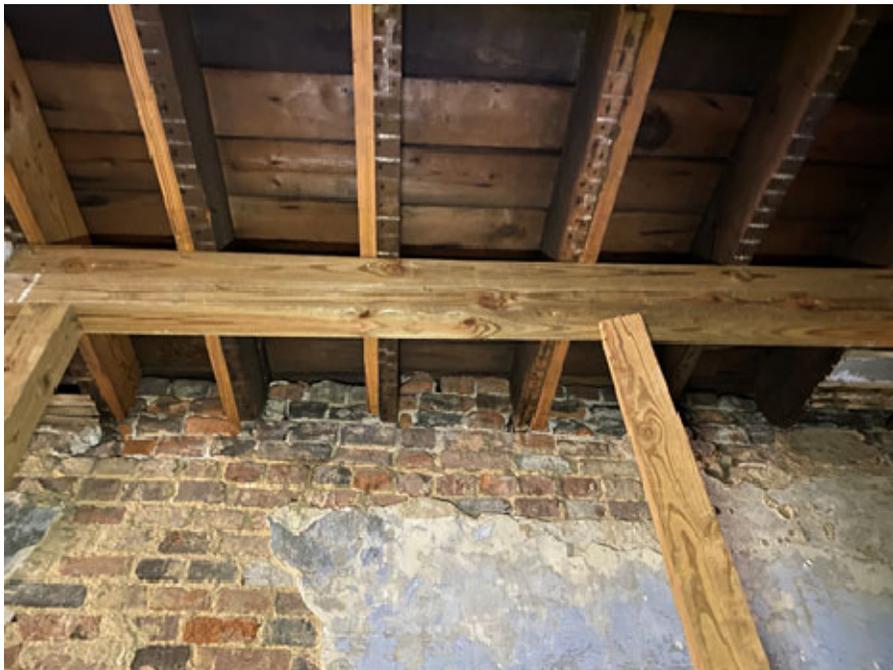
Photo 100 Shoring Bearing Condition at 86 North Main

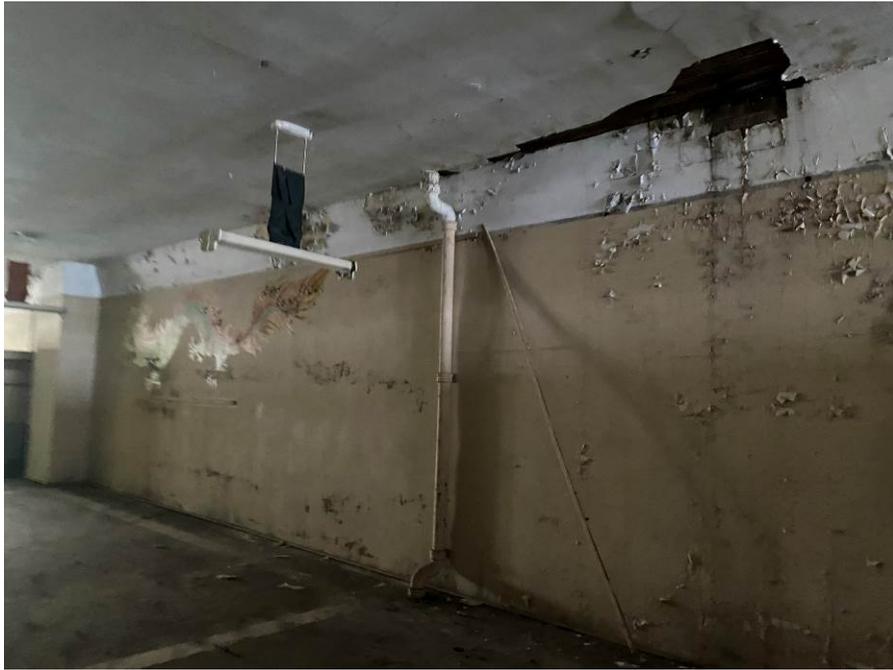
Photo 103 Water Exposure Damage to Covered Ceiling of Second Floor at 84 North Main

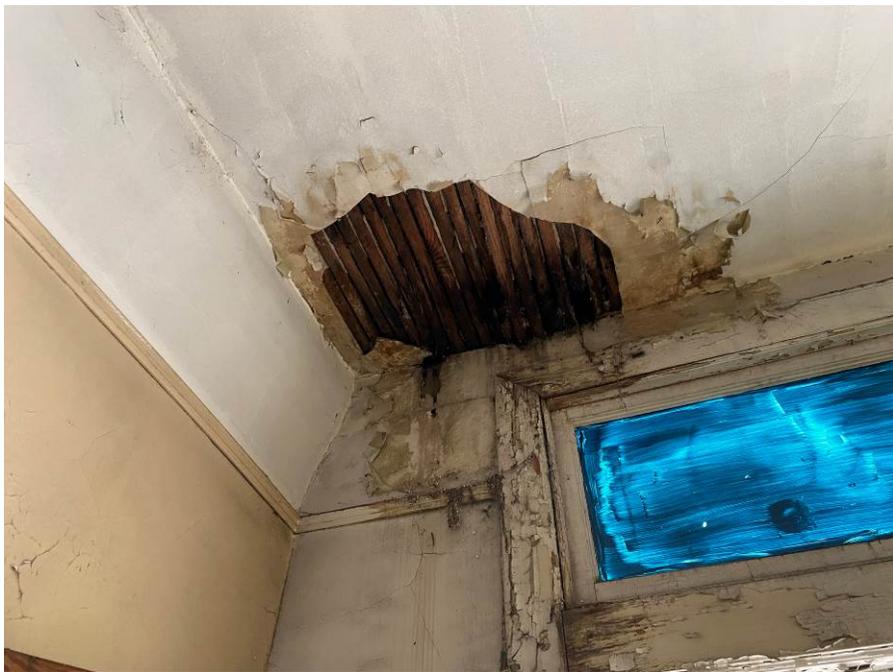
Photo 104 Water Damages in Ceiling of 84 North Main

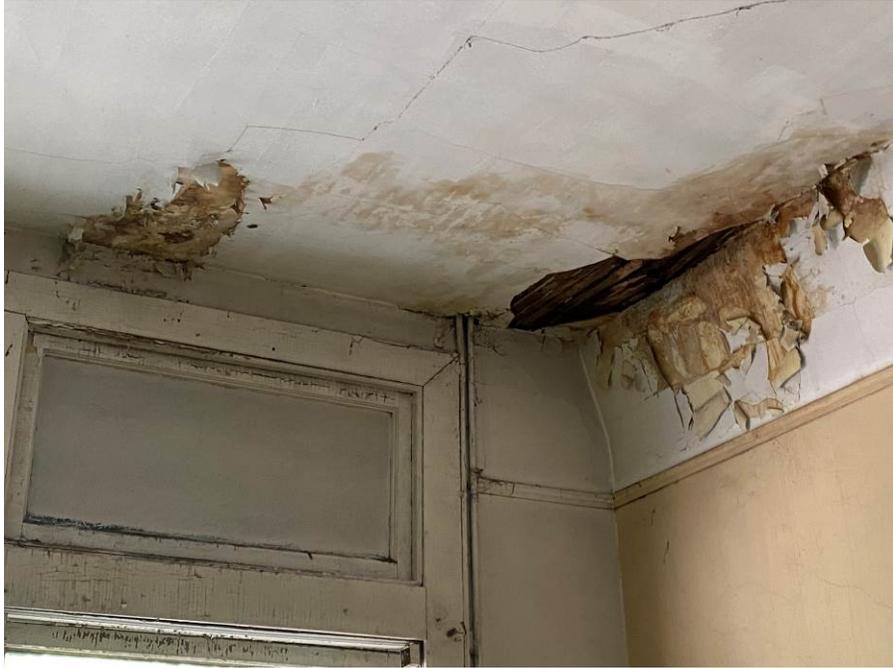
Photo 105 Water Damages in Ceiling at 84 North Main

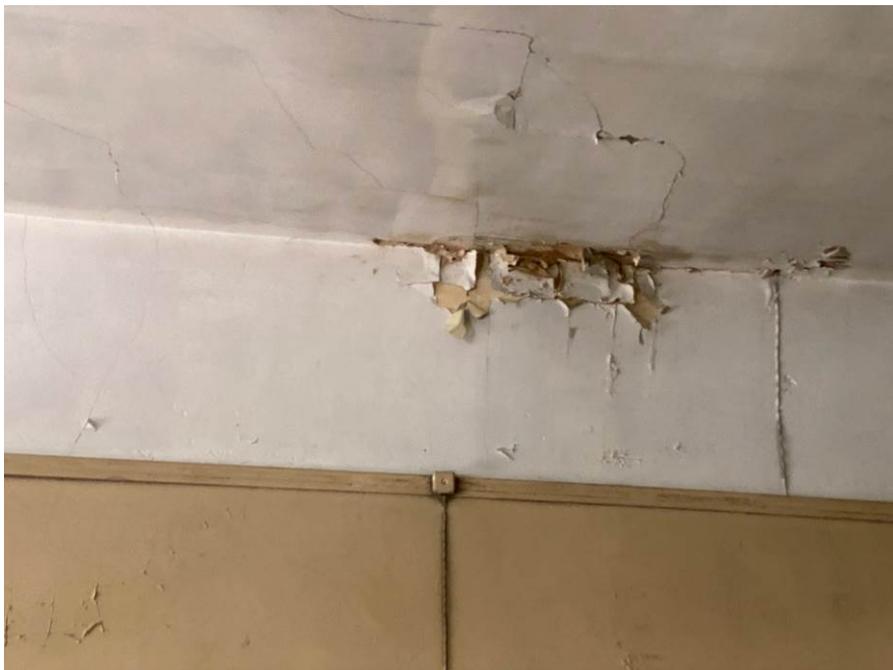
Photo 106 Water Exposure Damages to 84 North Main

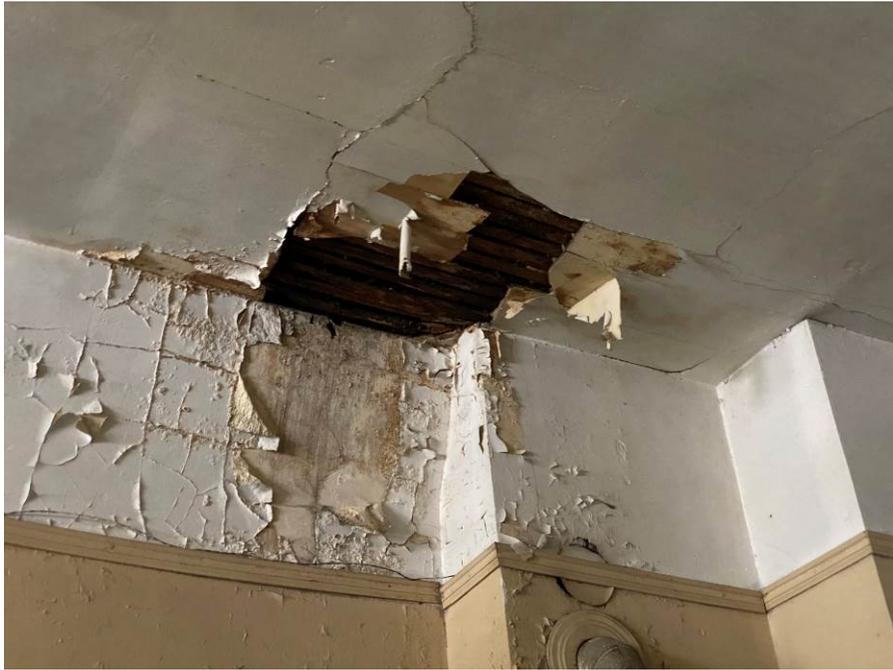
Photo 107 Water Damages to Ceiling and Lath of 84 North Main

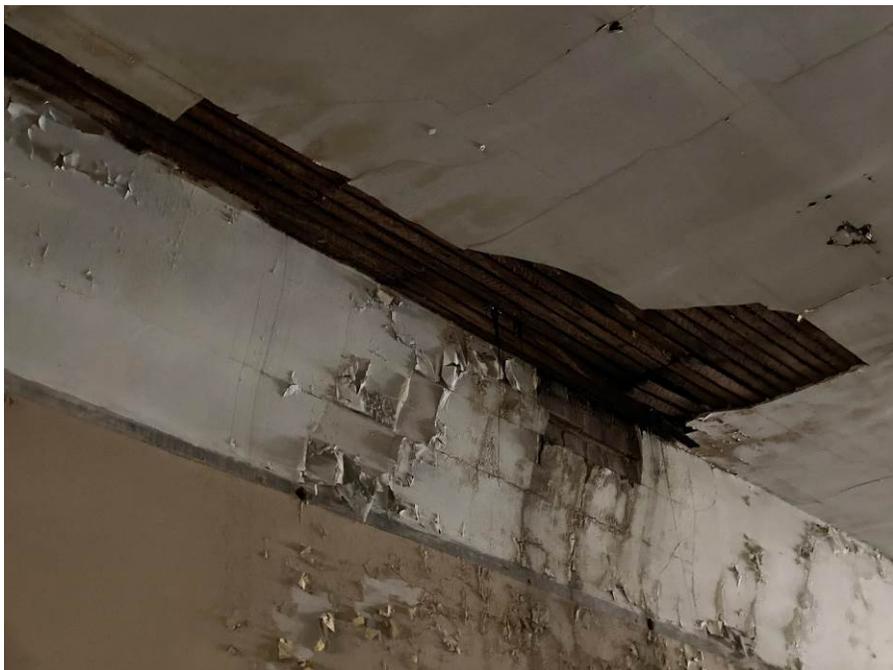
Photo 108 Water Damages to Ceiling on 84 North Main
