STRUCTURAL ENGINEERING ASSESSMENT REPORT

80-88 North Main Street, Memphis, Tennessee

Prepared for
Downtown Memphis Commission
Mr. Brett Roler

Job No. 2021105

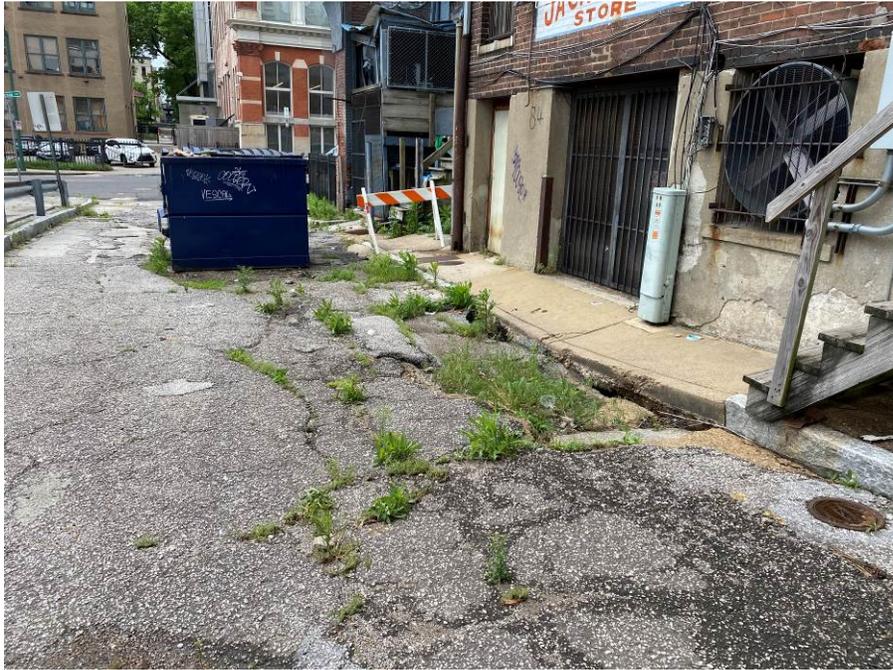
- The east side exterior of 84 North Main has an area of collapsed street and sidewalk. We recommend that the alley and sidewalk be repaired. Water is currently draining under the sidewalk and can effect the exterior wall of the structure if left unattended for too long. The building was not showing signs of

Photo 109 Collapsing Sidewalk and Pavement of November 6th Alley

settling at the time of observation; however, we recommend regular observation of this area until repairs have been completed. (Photos 109 through 110)

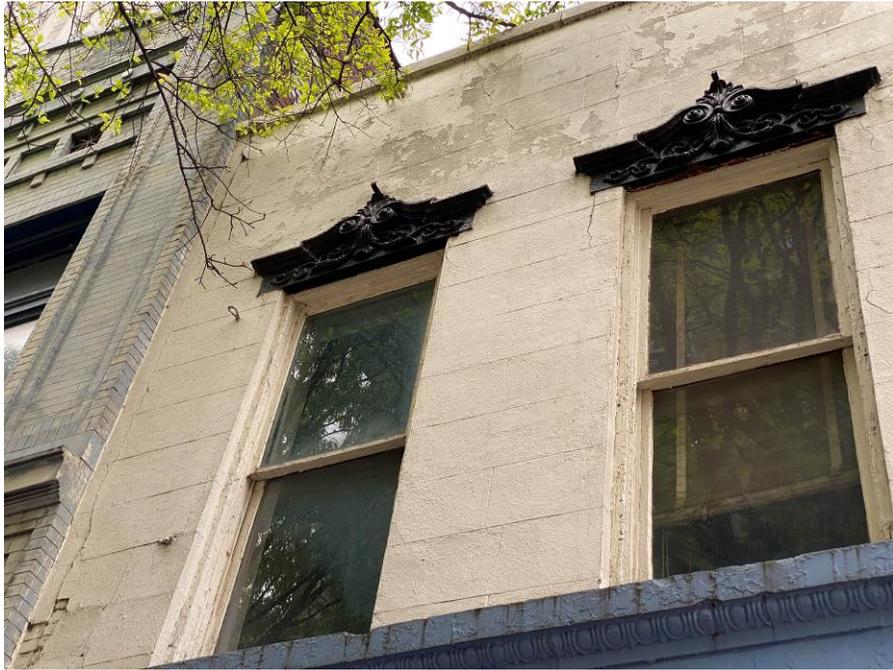
Photo 113 Peeling Coat of Masonry Coat on Condition o

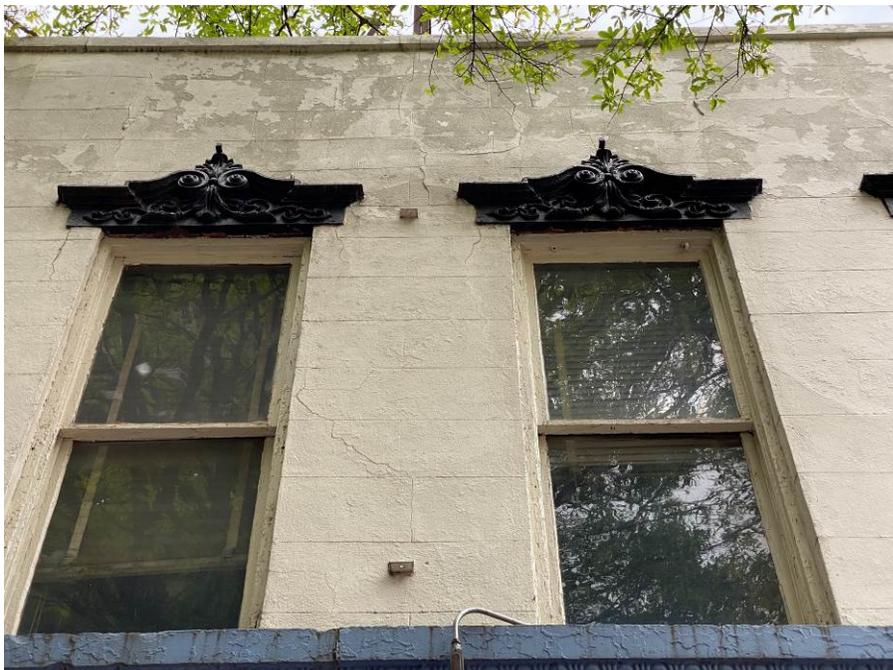
- We noted some exterior façade cracking on the scratch coating of the west façade of 80 North Main at the second floor. The cracking was not observed in the masonry from the inside and did not appear to be in the masonry exterior wall but just surface cracking through the coating. (Photos 111 through 116)

Photo 114 Parge Coat Cracking on Facade

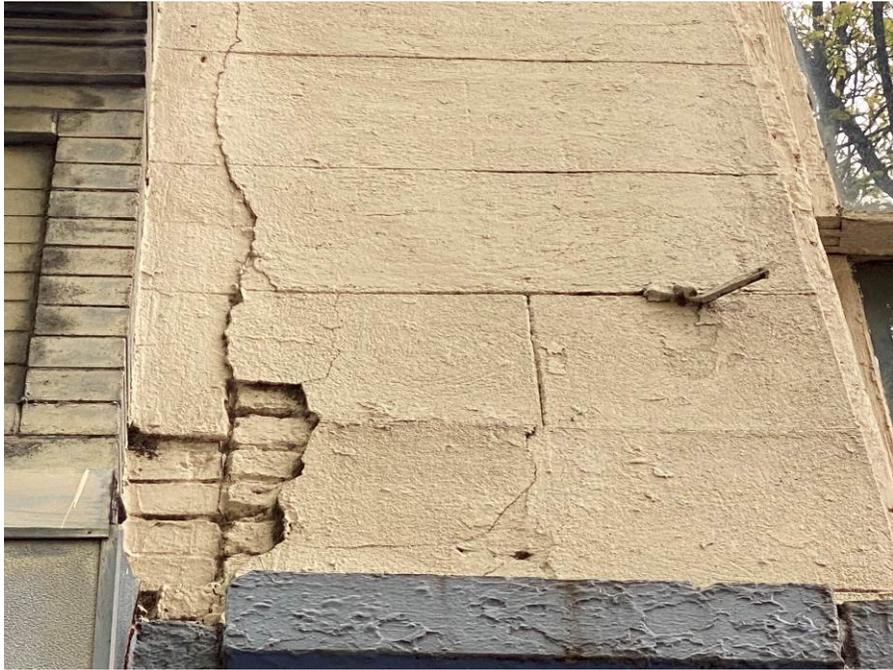
Photo 115 Cracking Parge Coating

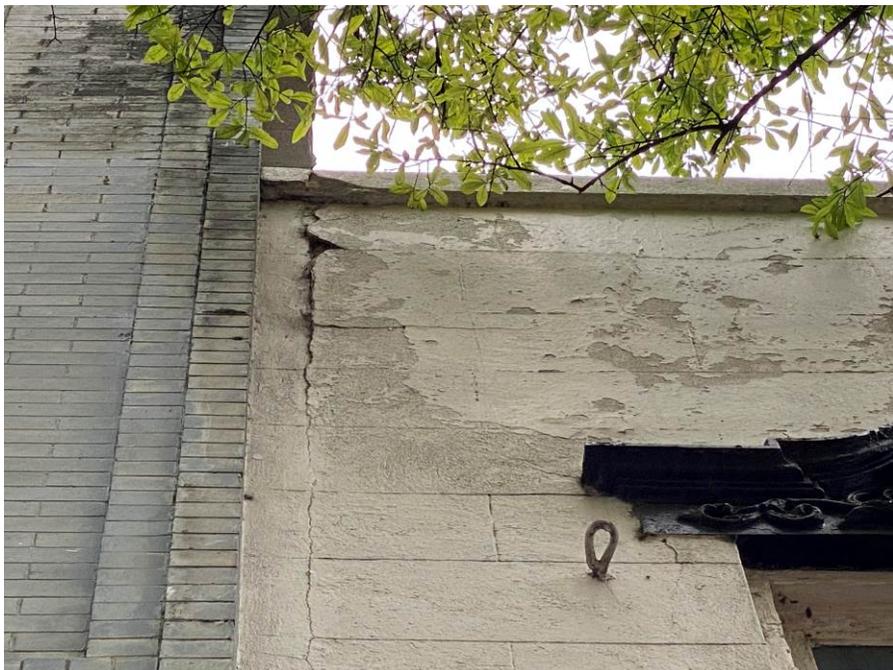
Photo 116 Cracking Parge Coating

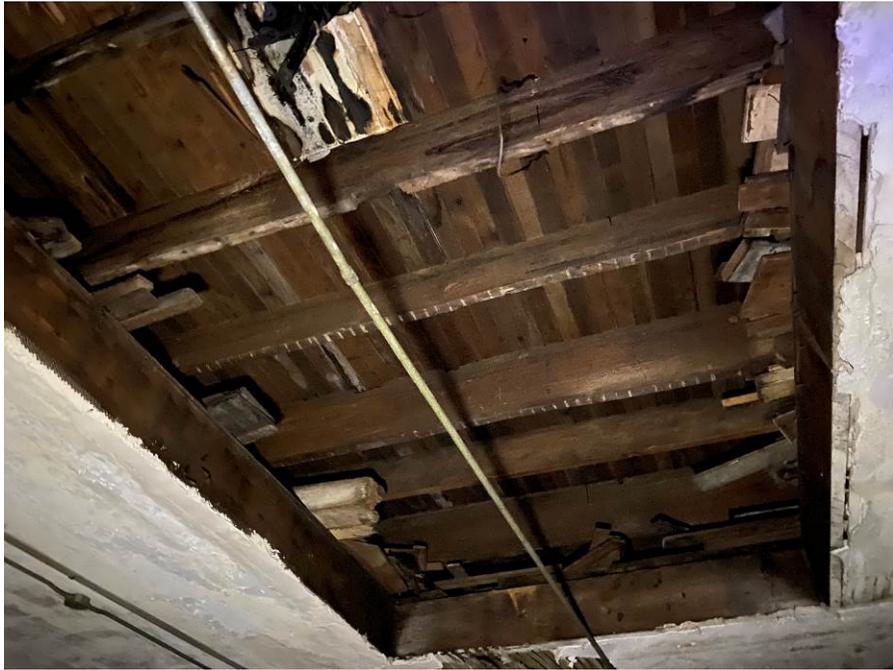
- The roof structure appeared to be in fair condition during the time of observations at 80 North Main. There were some locations where long-term exposure to moisture has caused deterioration of the 1x roof decking that will require replacement. Due to safety concerns, roof access should be prevented until the roof decking and members have been properly remedied. We also recommend a new roof system be installed to prevent future moisture intrusion. (Photos 117 through 118)

Photo 117 Decking Water Stain Damages at Roof of 80 North Main

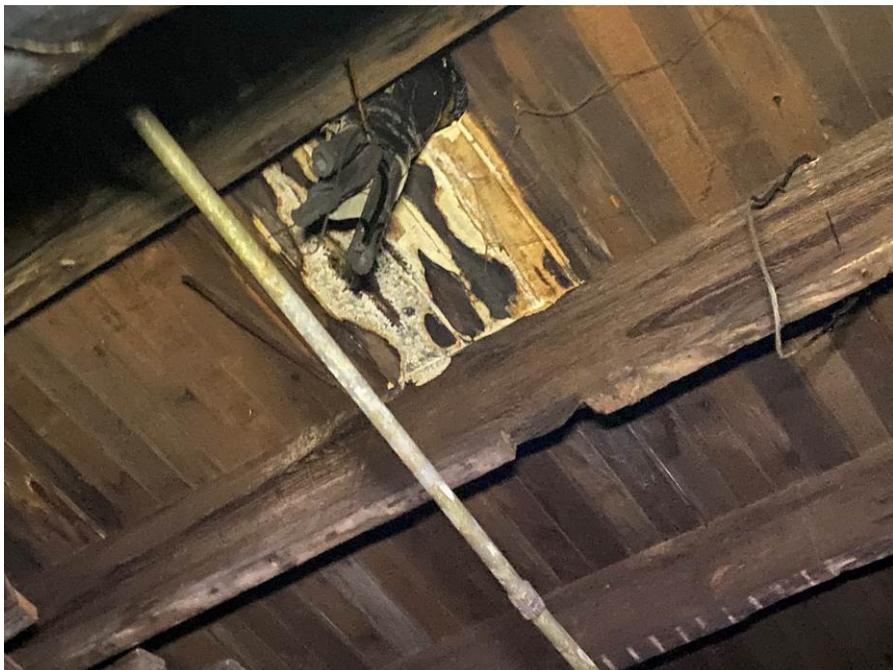
Photo 118 Water Stain Damages at 80 North Main

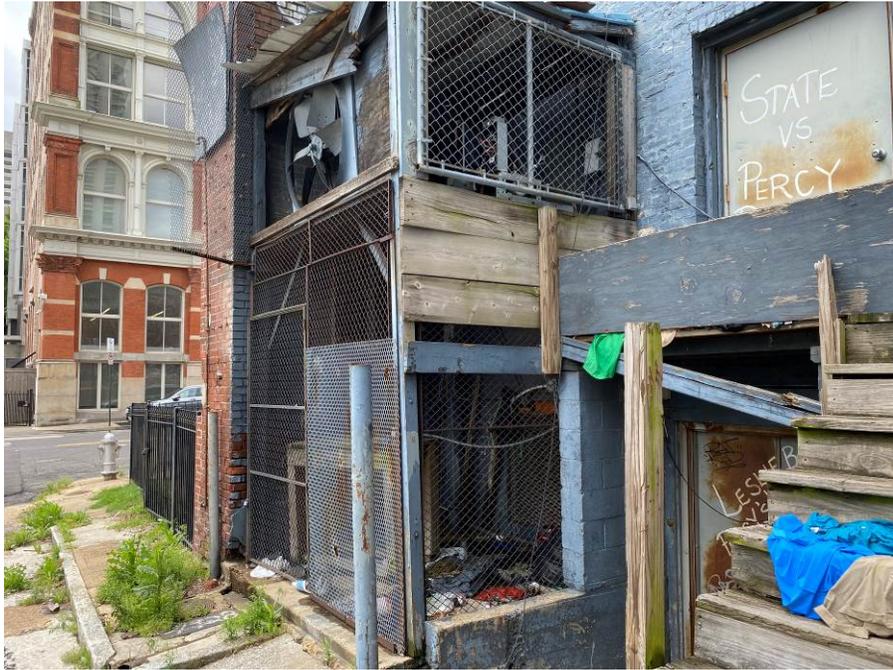
- Wood joists were damaged below the roof ladder on 80 North Main. We recommend that the wood joists be replaced to prevent possibly injury from accessing the roof ladder. Until the joists have been repaired, we recommend no access to the roof of 80 North Main. (Photos 119 through 120)

Photo 119 Sheared Framing Members at Mechanical Roof on 80 North Main

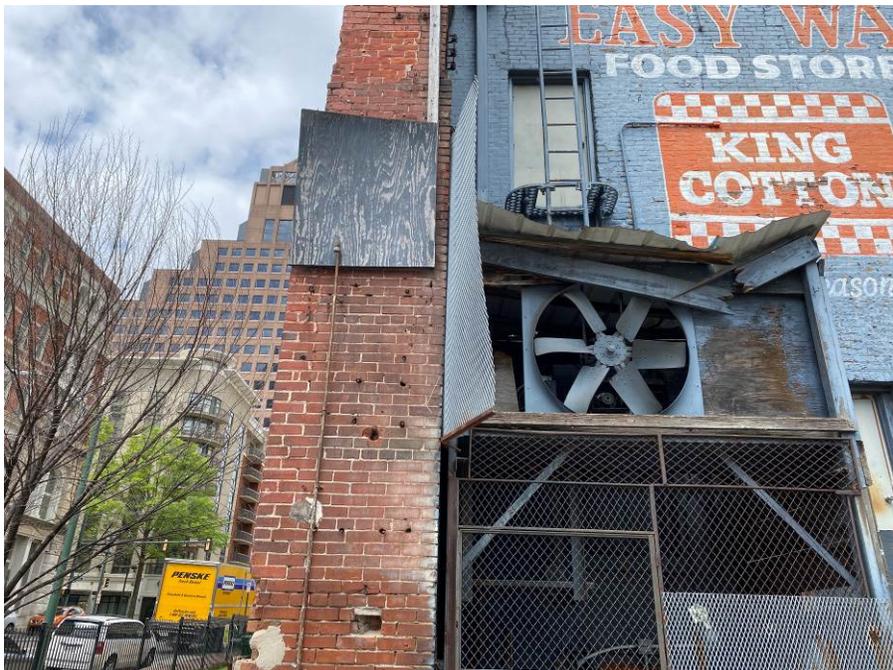
Photo 120 Damaged Roof Structure at 80 North Main
