STRUCTURAL ENGINEERING ASSESSMENT REPORT

80-88 North Main Street, Memphis, Tennessee

Prepared for
Downtown Memphis Commission
Mr. Brett Roler

Job No. 2021105

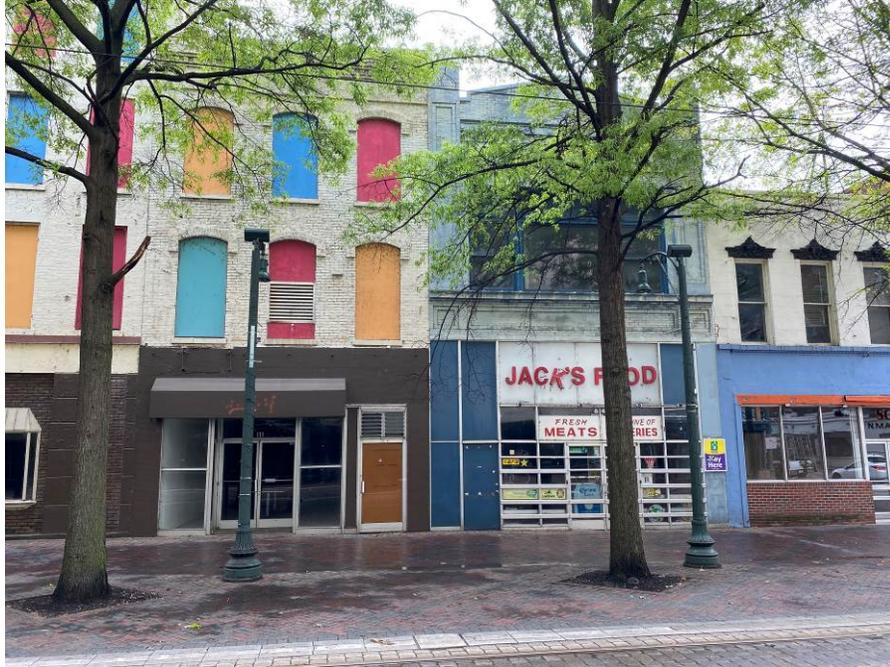
Photo 1 Front Elevation at North Front Street

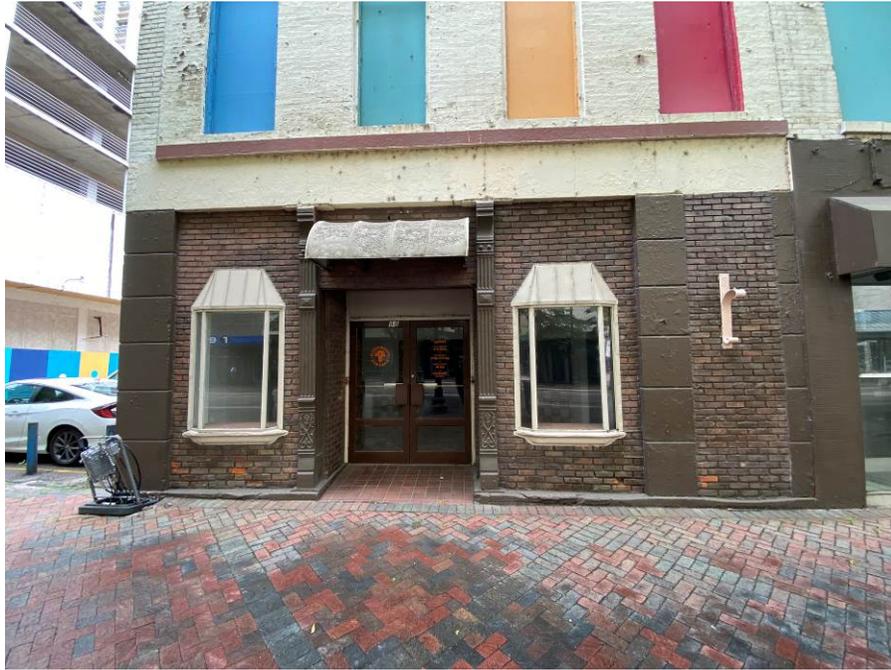
Photo 3 Front of 88 North Main

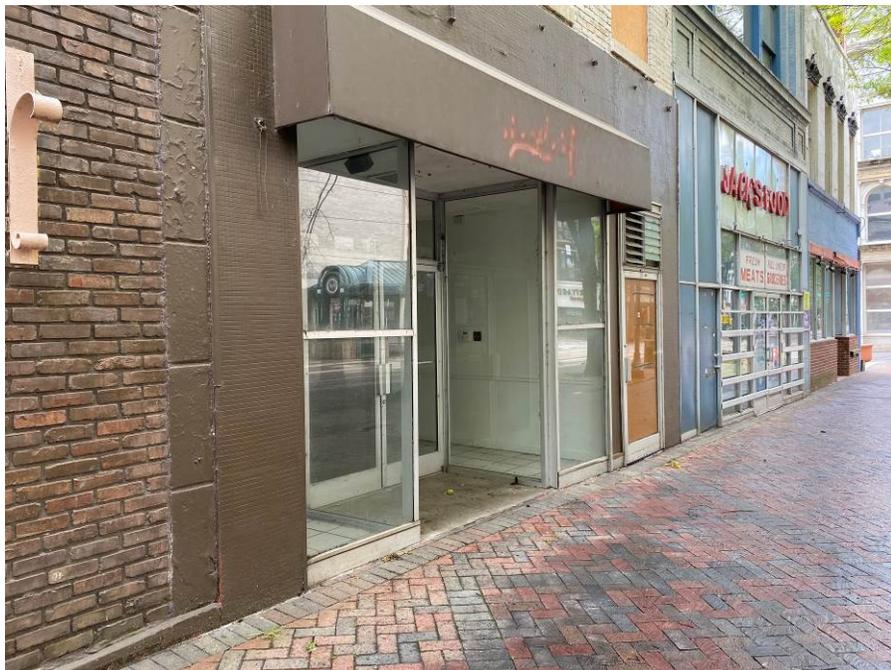
Photo 4 Front Elevation of 86 North Main

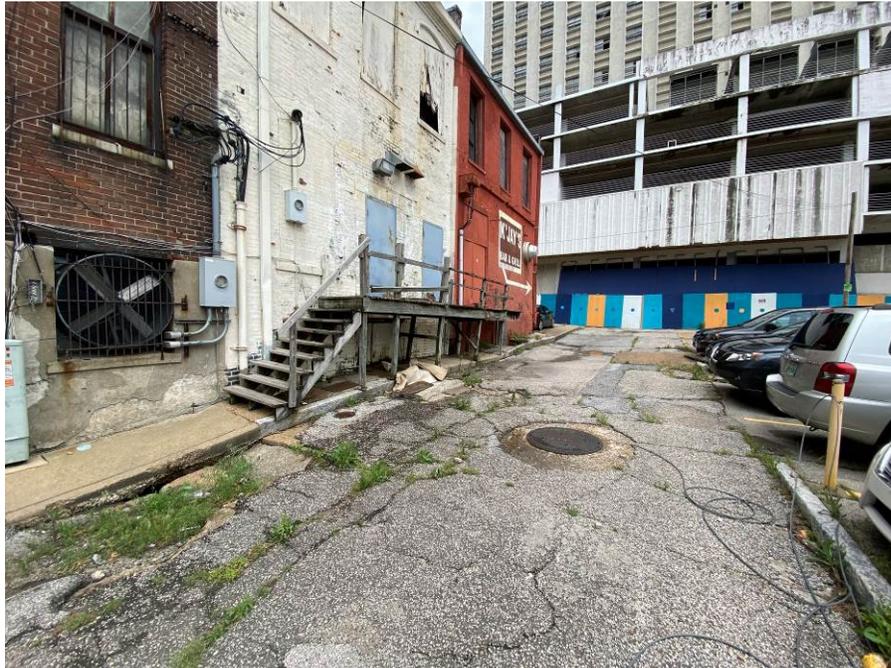
Photo 5 Rear Elevation at November 6th Alley

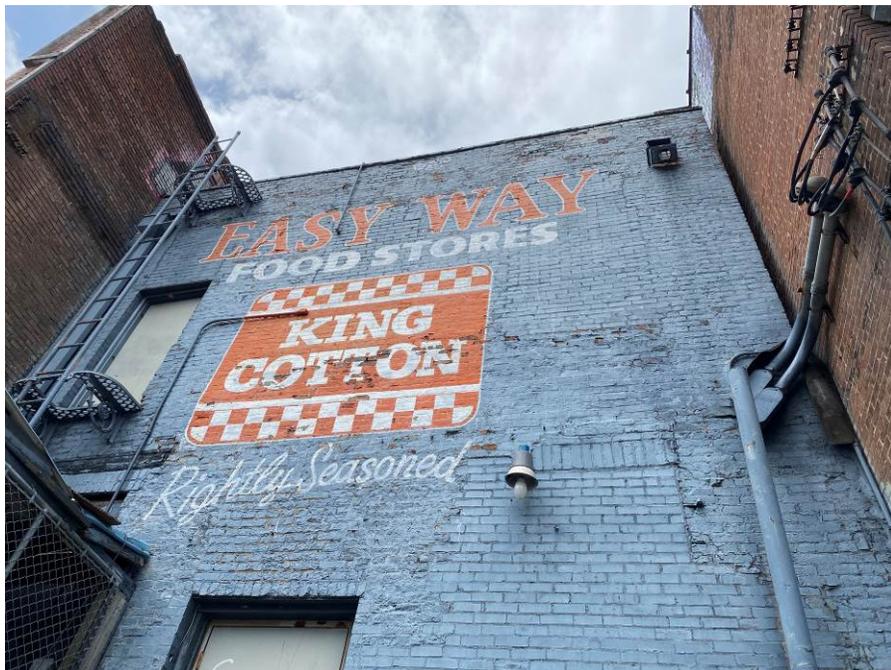
Photo 6 Condition of Masonry at Rear on 80 North Main

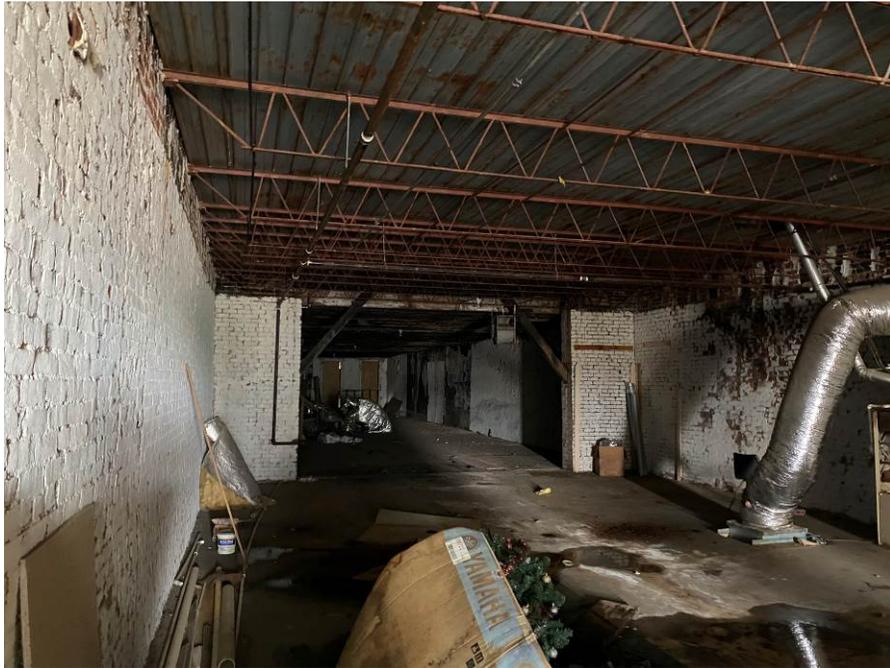
Photo 7 Second Floor General Condition of 88 North Main

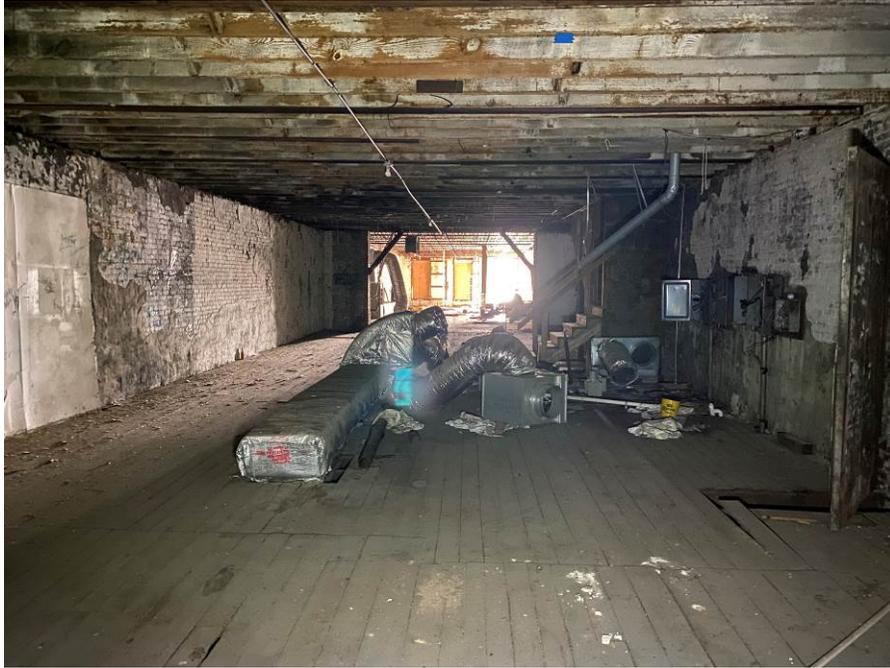
Photo 9 Condition of 88 North Main Second Floor

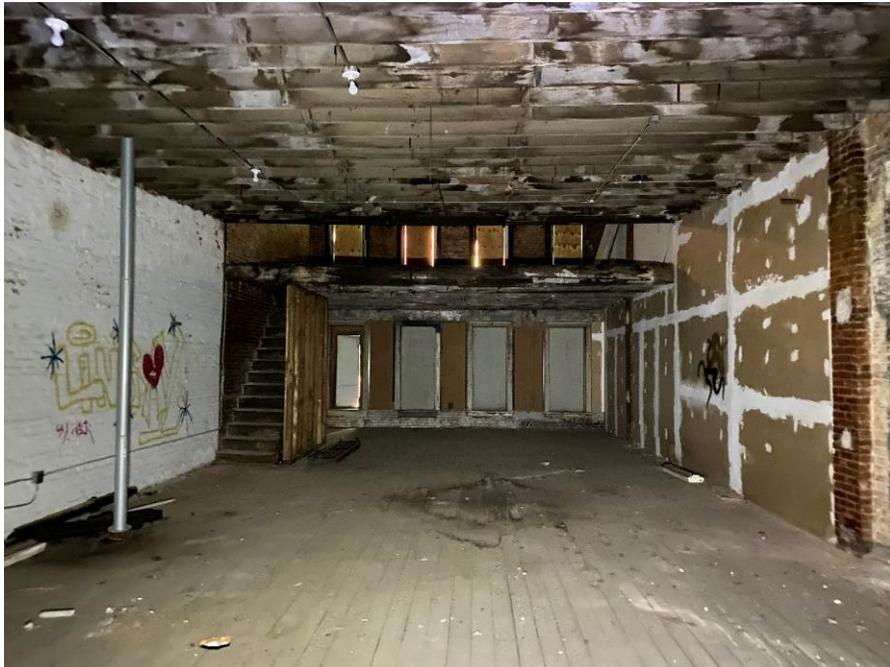
Photo 10 Condition of 88 North Main

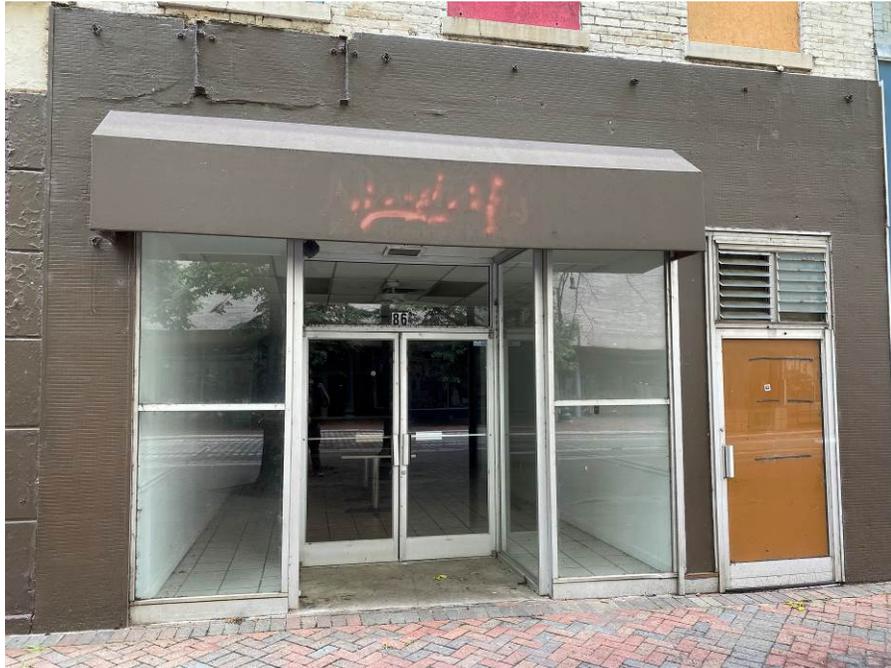
Photo 11 Front Elevation at 86 North Main

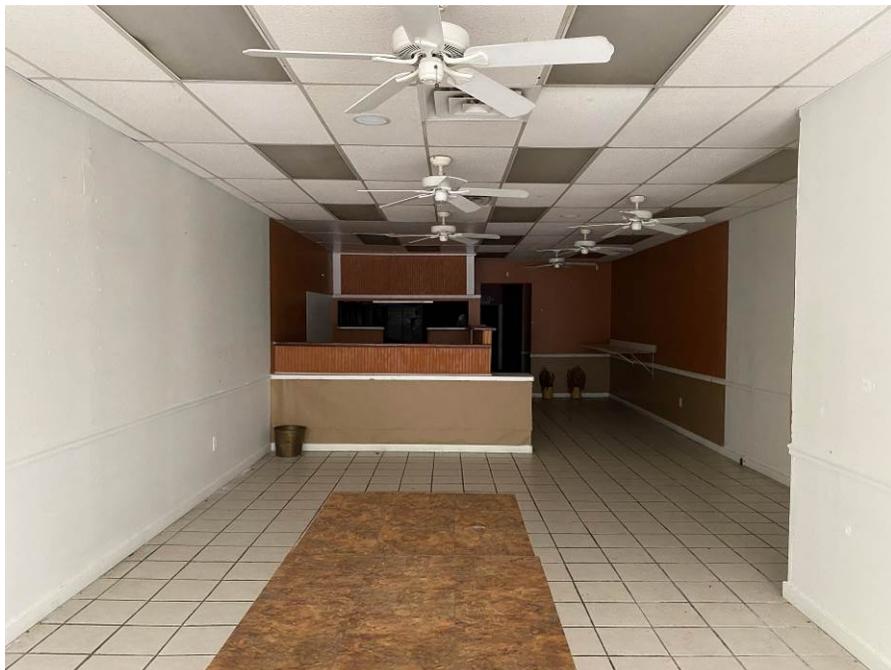
Photo 12 Interior General Condition of First Floor at 86 North Main

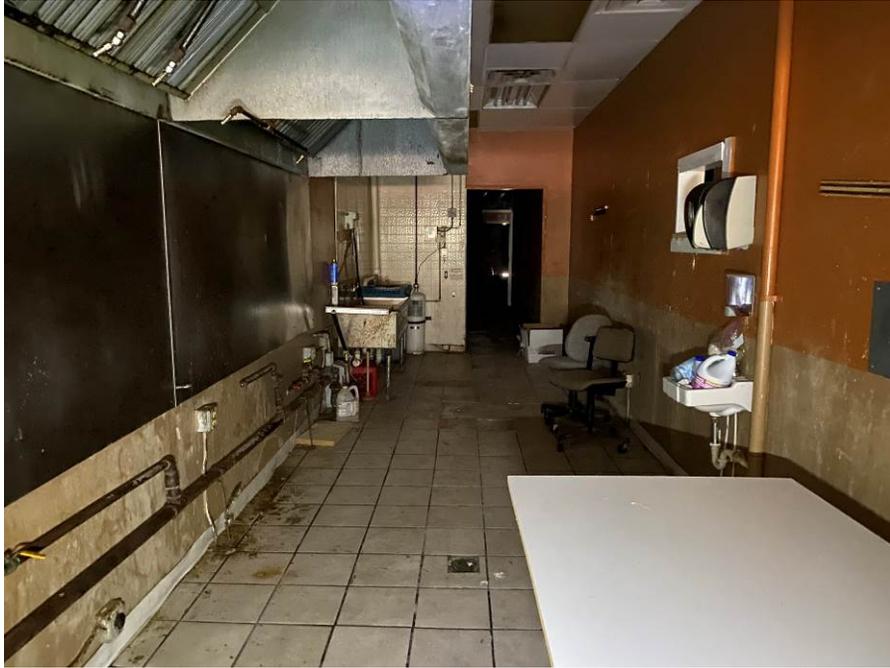
Photo 13 General Interior Kitchen at First Floor of 86 North Main

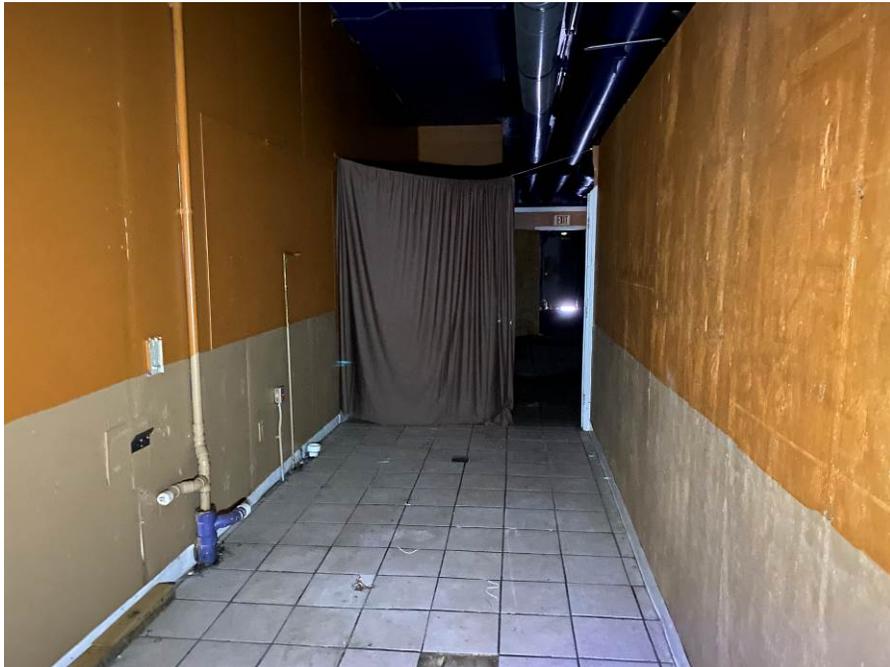
Photo 14 General Condition of 86 North Main

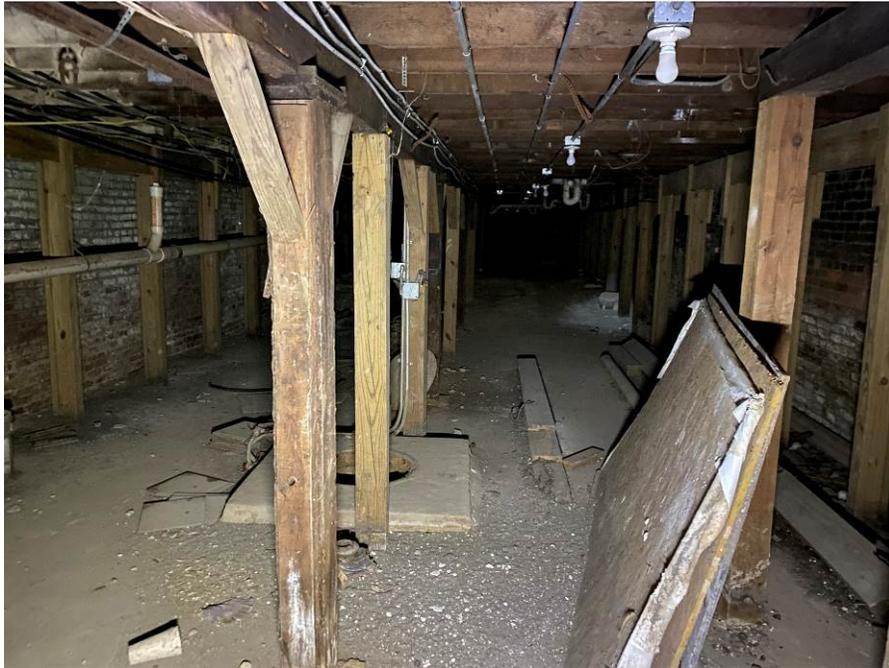
Photo 15 General Basement Condition of 86 North Main

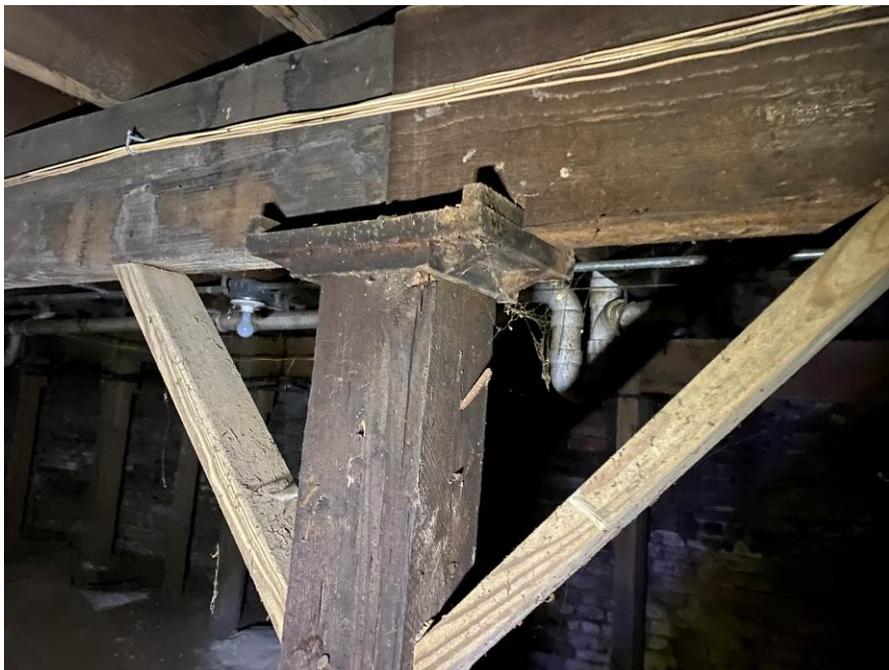
Photo 16 General Connections at Basement in 86 North Main Basement

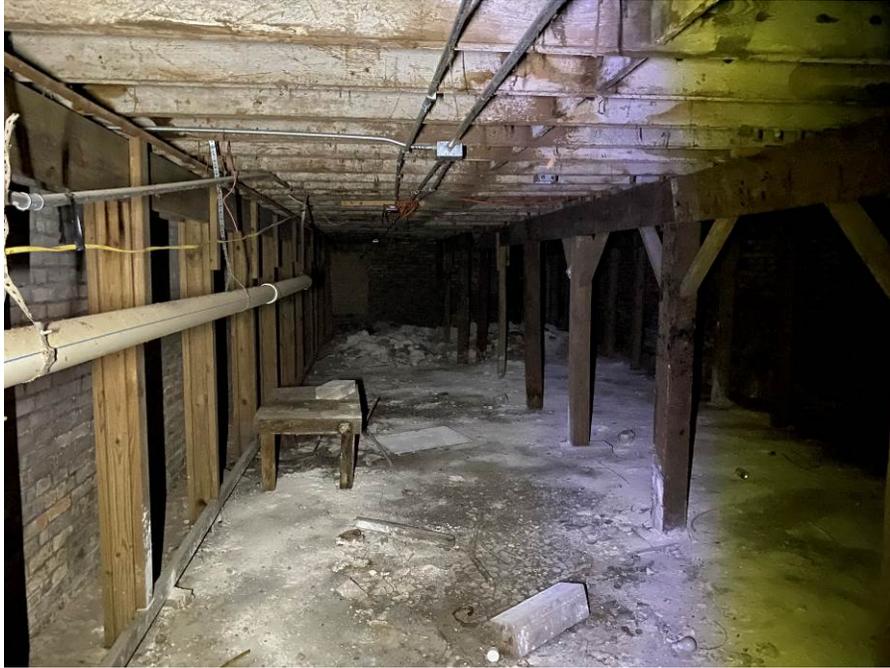
Photo 17 86 North Main Basement Framing

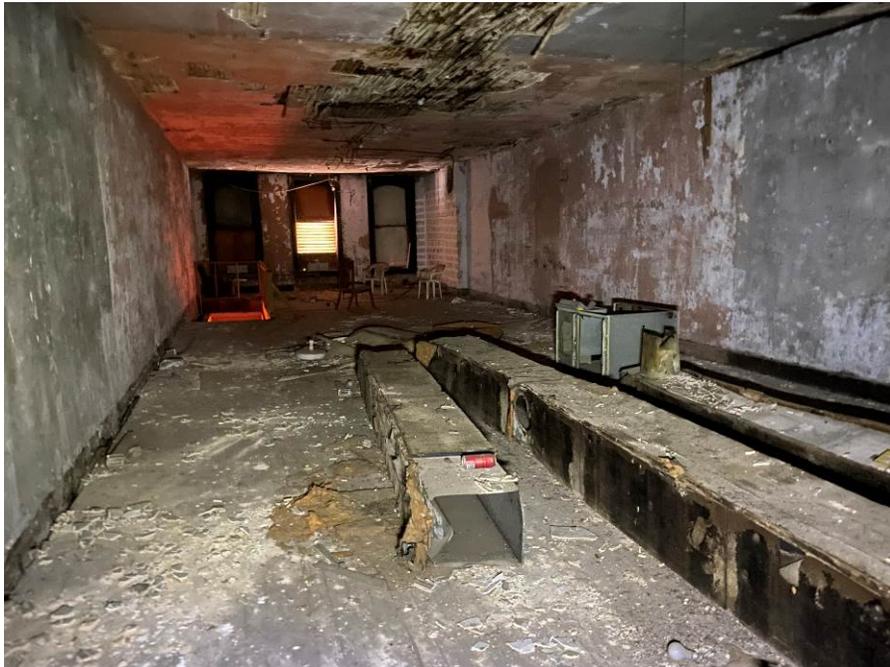
Photo 18 Second Floor Framing General Condition of 86 North Main

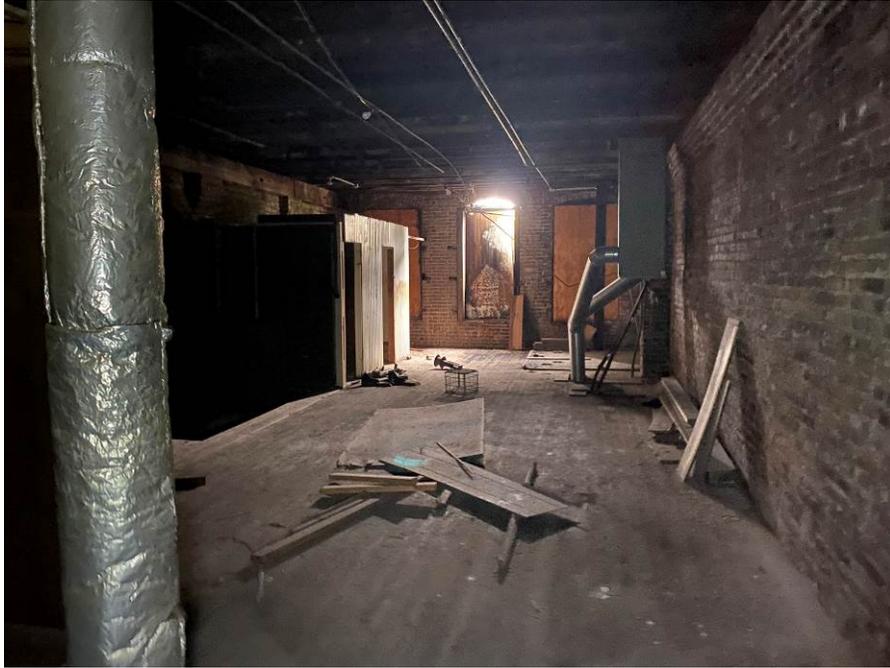
Photo 19 86 North Main General Conditions

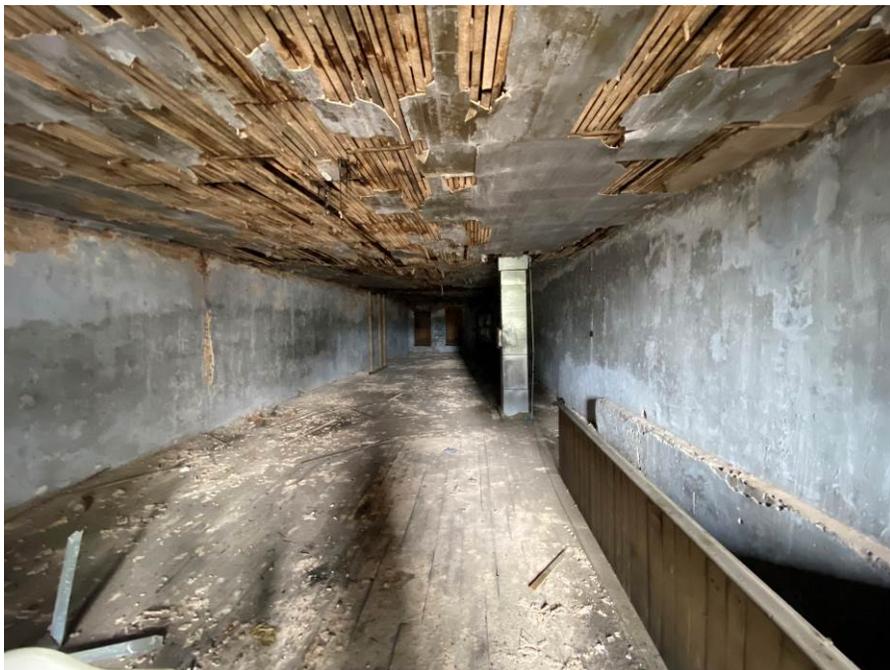
Photo 20 86 North Main General Framing Condition

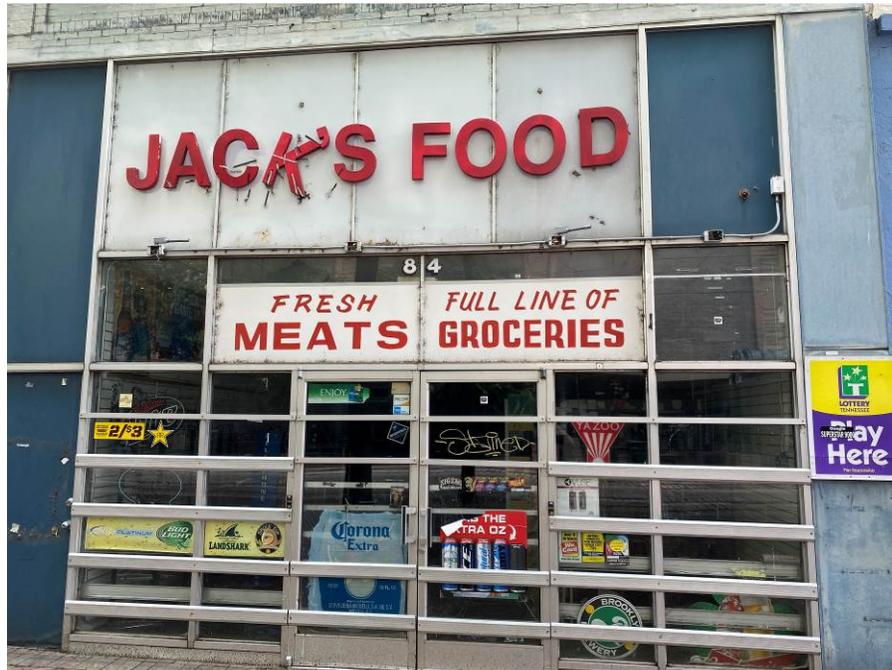
Photo 21 Front Elevation of 84 North Main

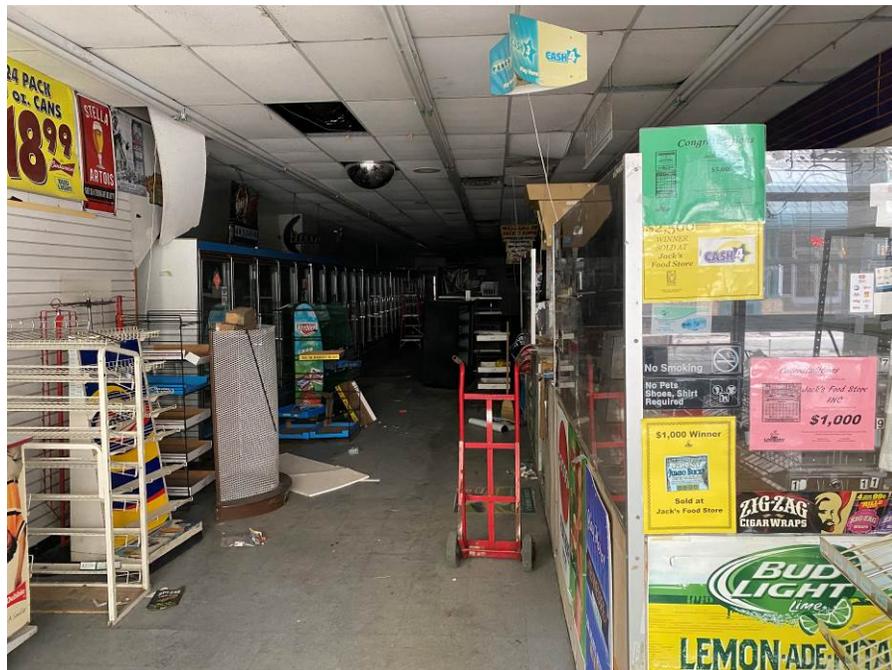
Photo 22 General Condition of 84 North Main Ground Floor

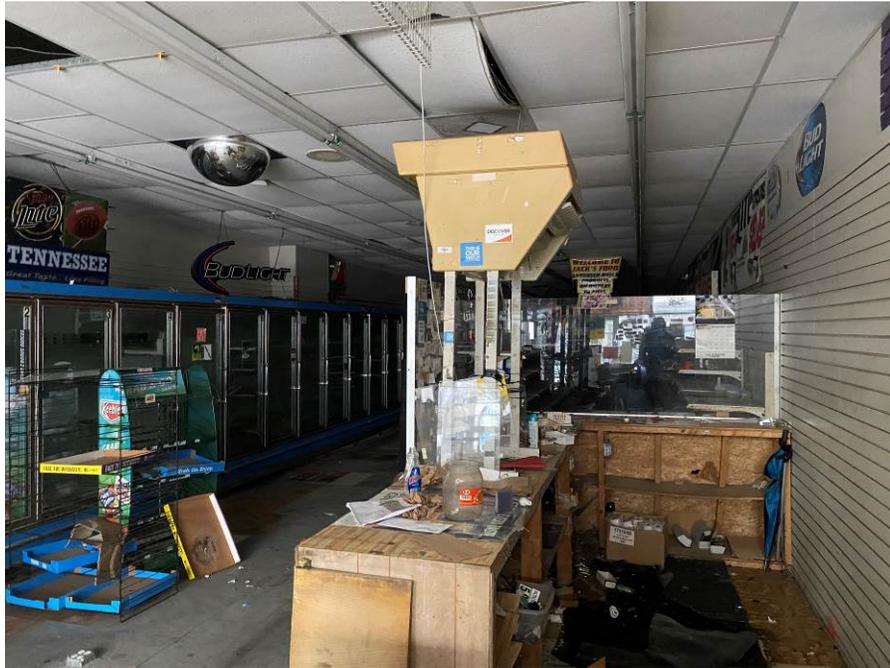
Photo 23 Interior General Condition of Ground Floor at 84 North Main

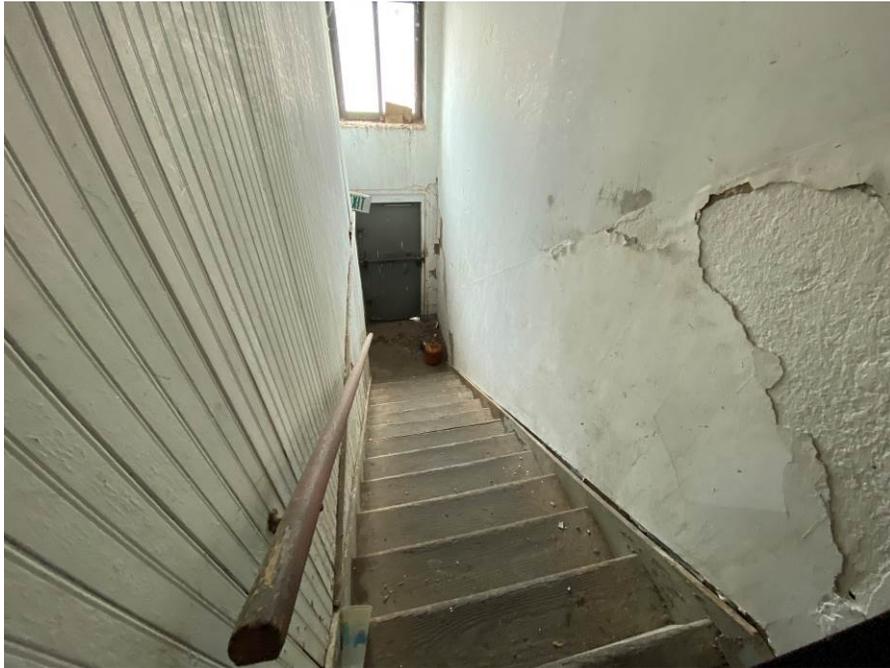
Photo 25 Stairwell at 84 North Main Rear

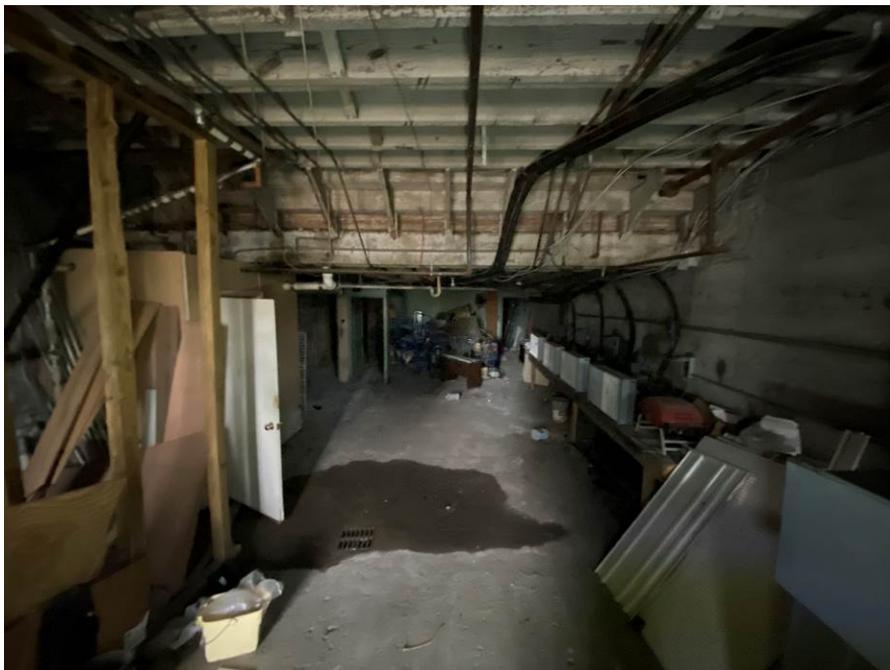
Photo 26 Basement Framing of 84 North Main

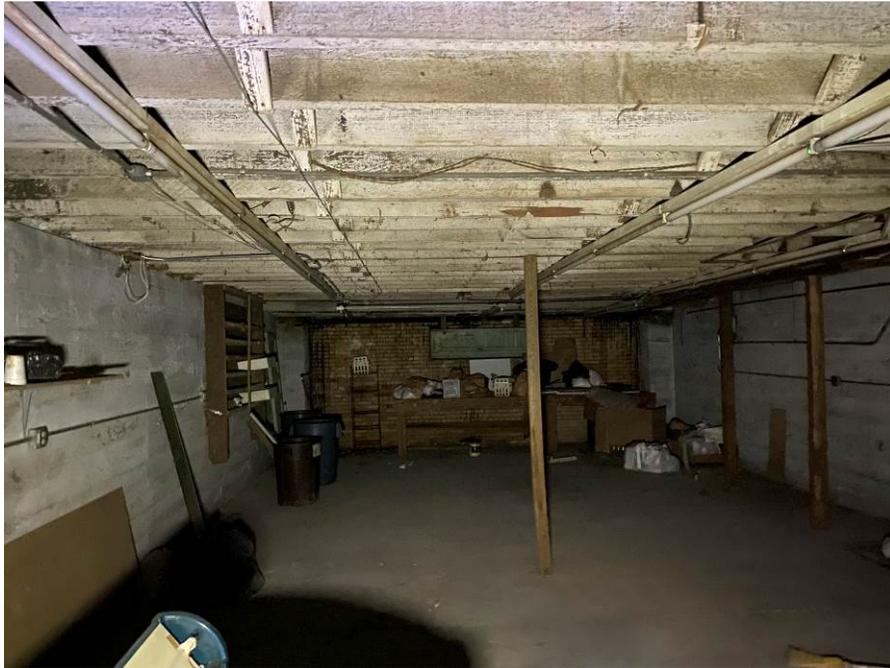
Photo 27 Basement Condition of 84 North Main

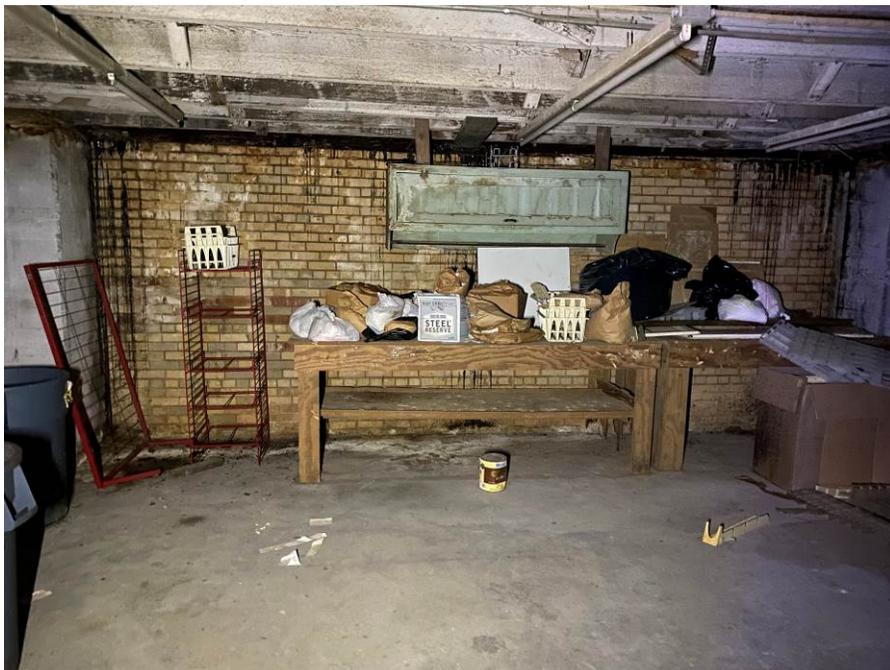
Photo 28 Basement Wall and Framing in 84 North Main

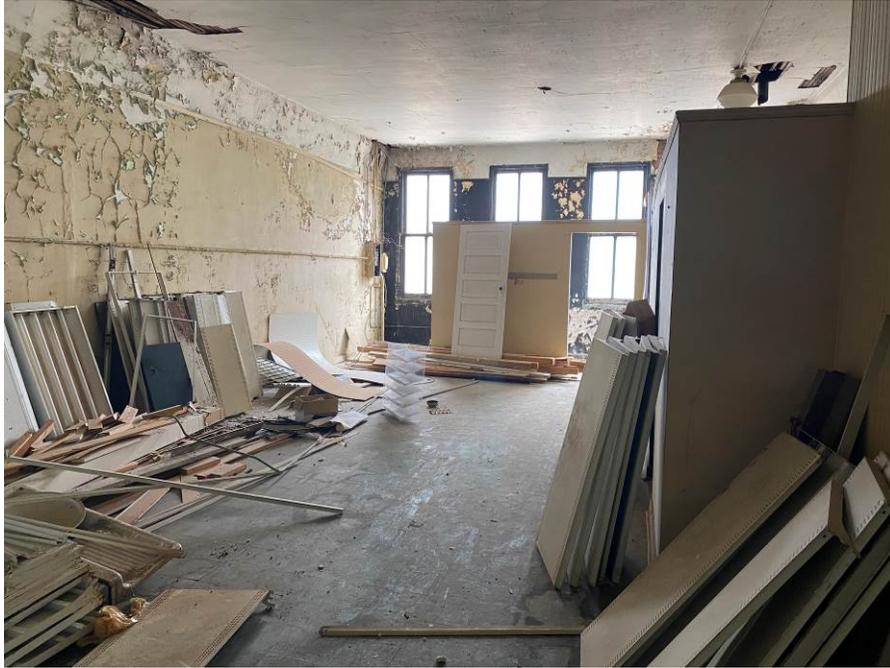
Photo 29 Second Floor Framing at 84 North Main

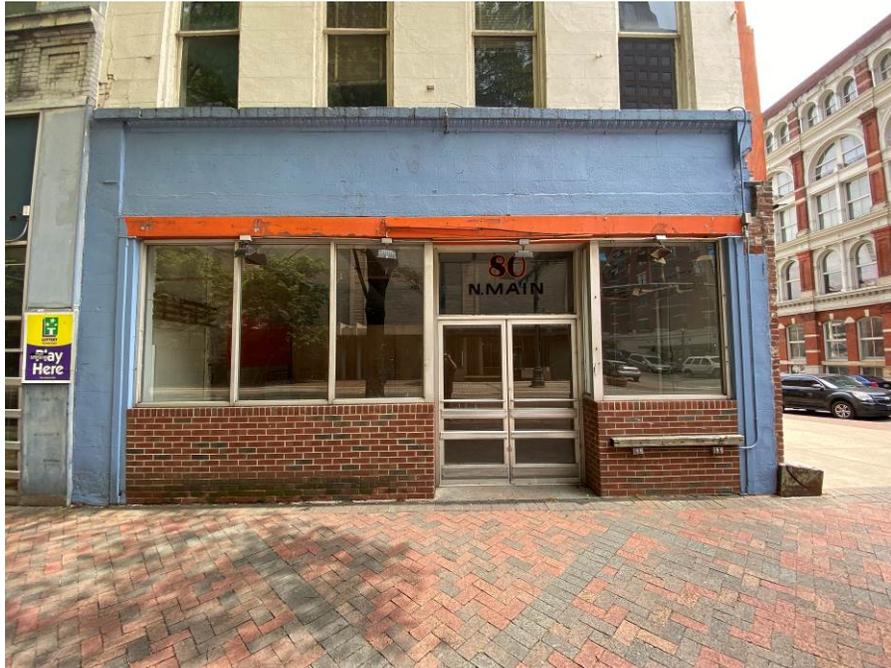
Photo 31 80 North Main Exterior General Condition

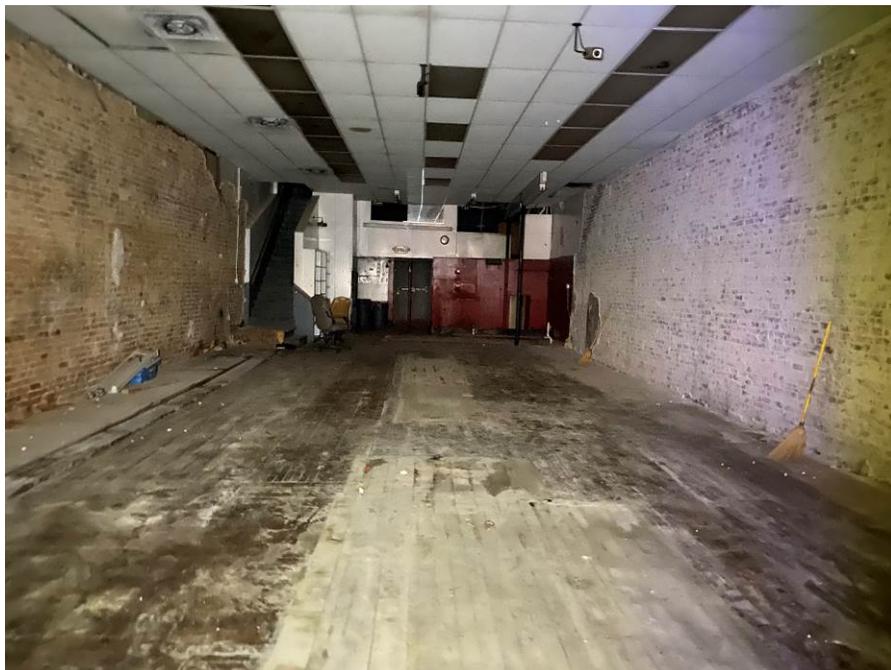
Photo 32 First Floor General Condition of 80 North Main

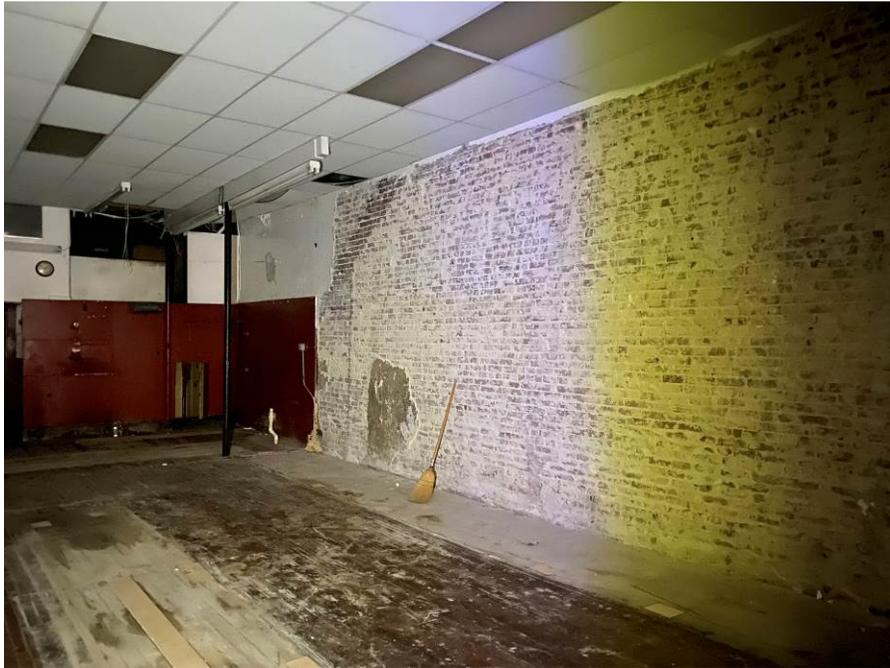
Photo 33 General interior Condition of 80 North Main

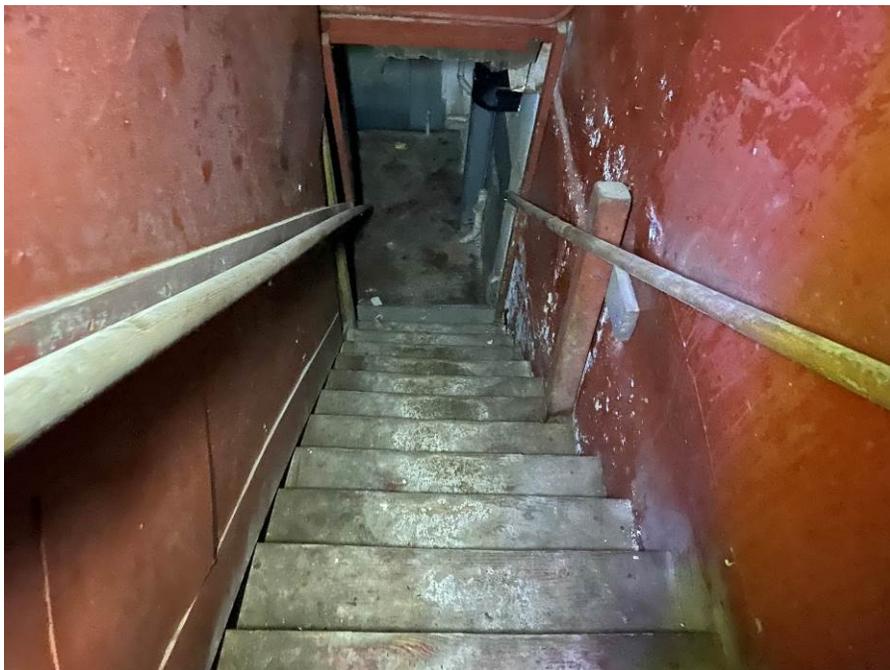
Photo 34 Stair to Basement in 80 North Main

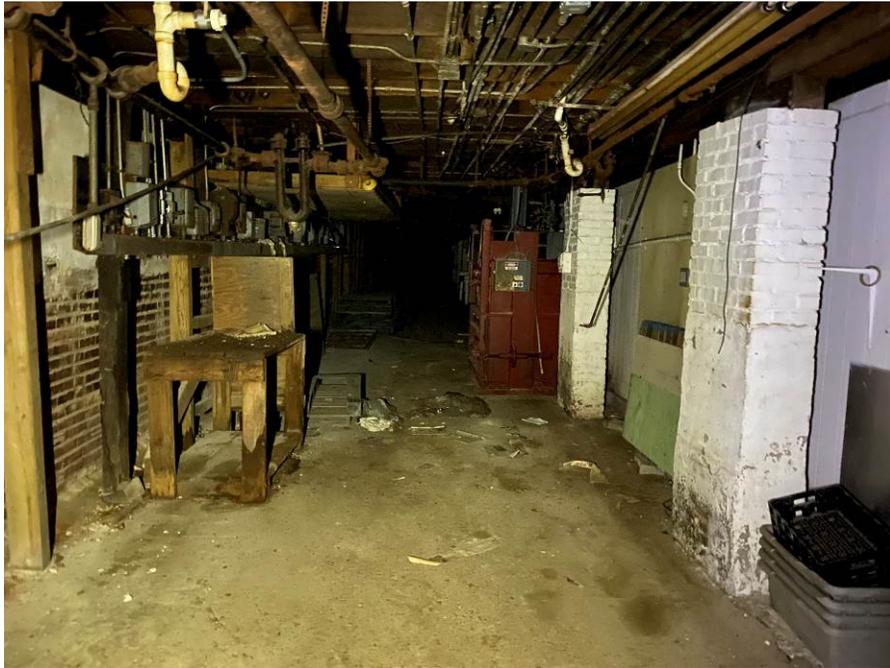
Photo 35 Basement Framing of 80 North Main

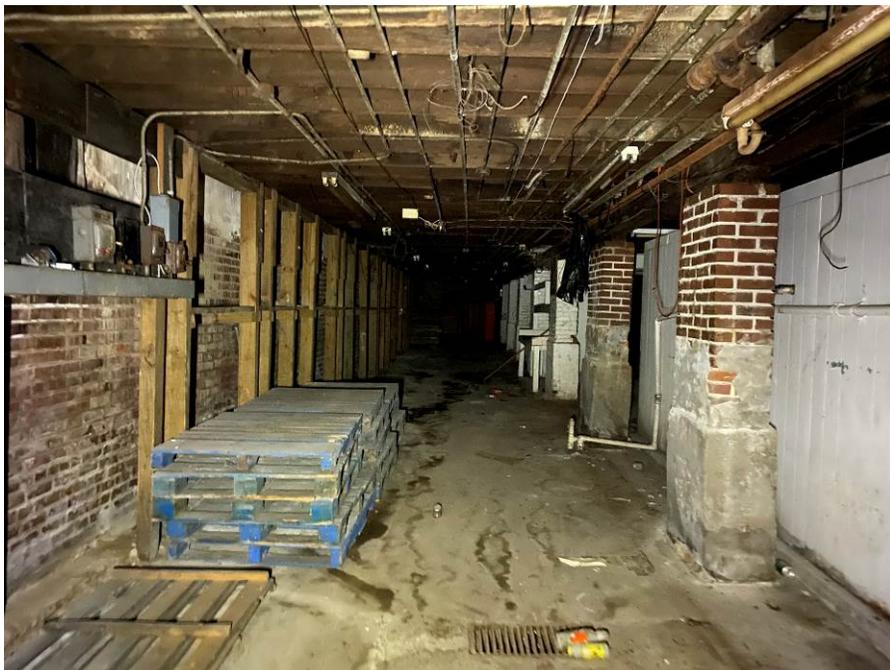
Photo 36 Masonry Pilasters in Basement of 80 North Main

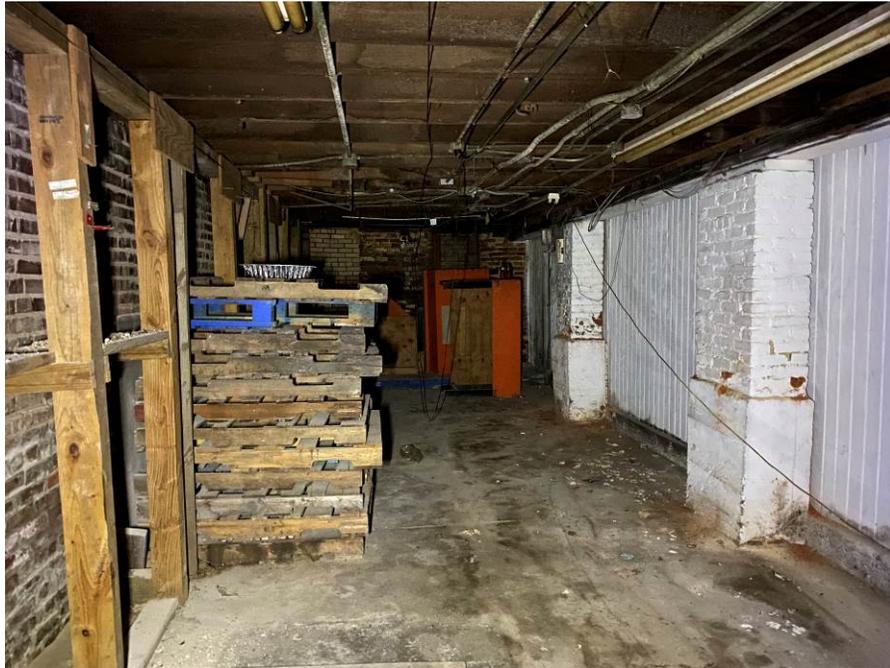
Photo 37 General Condition of Framing in Basement of 80 North Main

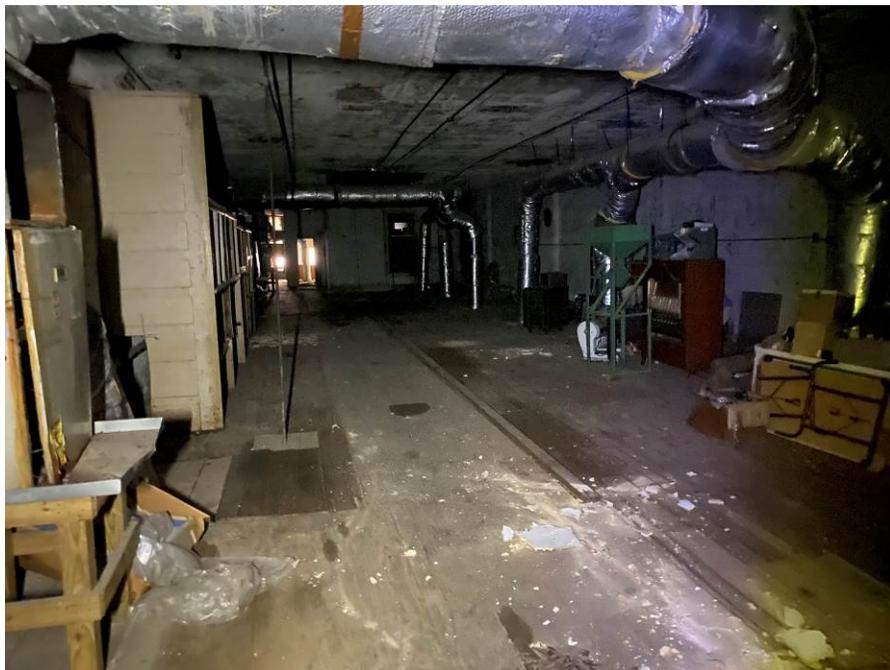
Photo 38 General Condition of 80 North Main Second Floor

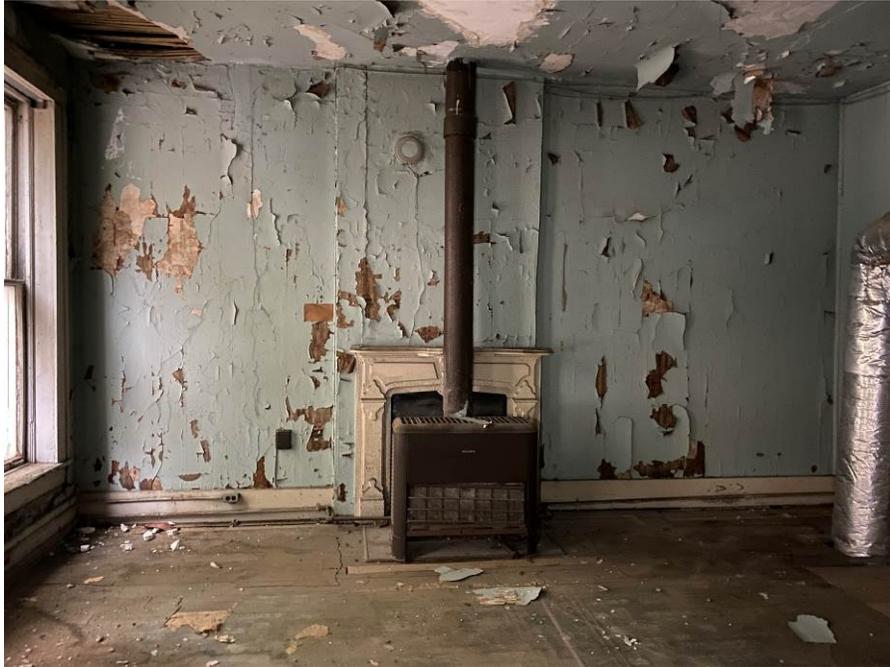
Photo 39 Second Floor of 80 North Main

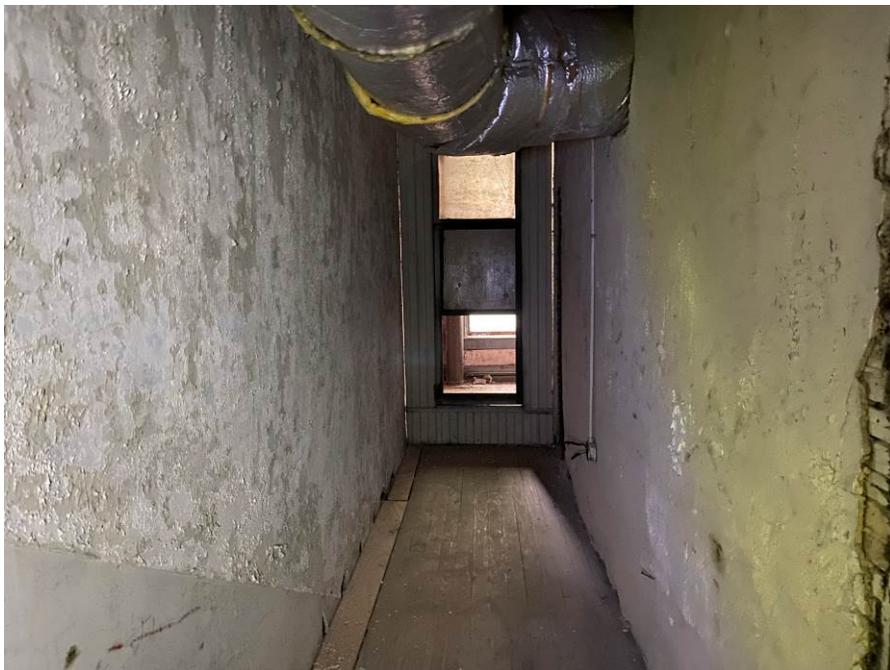
Photo 40 Hallway on Second Floor of 80 North Main

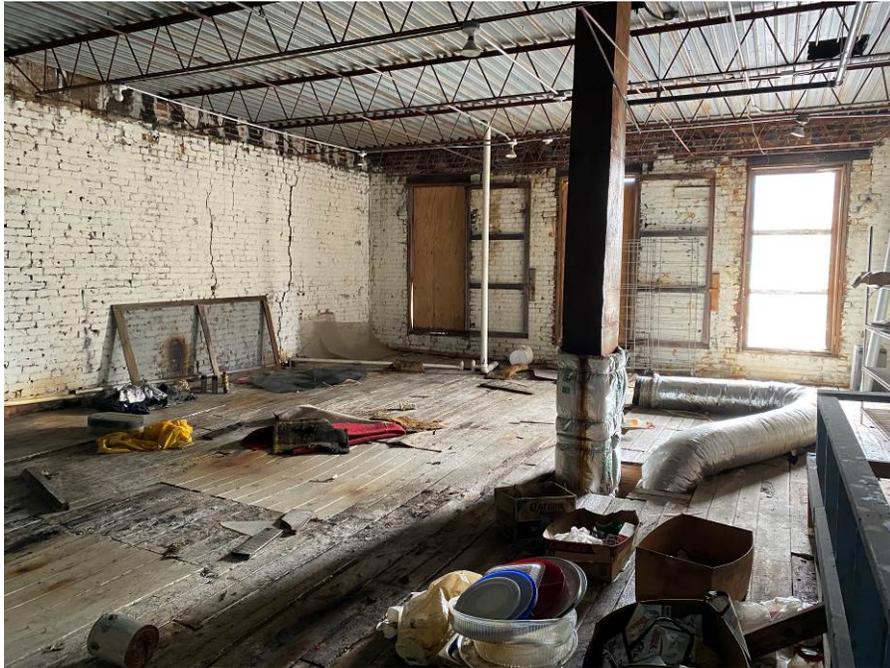
approximately an inch in magnitude and were located on the ground floor and the second story northern exterior wall. The cracks were generally vertical in orientation and traveled through both the brick and the mortar. The cracking had the appearance of aged cracking and did not appear active; however, we recommend that the cracks be repaired to prevent additional separation of the masonry materials. There does appear to be impact damage from the exterior of the building located adjacent to the parking lot on the north side of the building. We recommend tuck pointing the exterior cracks to prevent water infiltration into the building and to prevent additional movement of the bearing wall (Photos 41 through 48)

Photo 41 Masonry Crack on 88 North Main
