STRUCTURAL ENGINEERING ASSESSMENT REPORT

80-88 North Main Street, Memphis, Tennessee

Prepared for
Downtown Memphis Commission
Mr. Brett Roler

Job No. 2021105

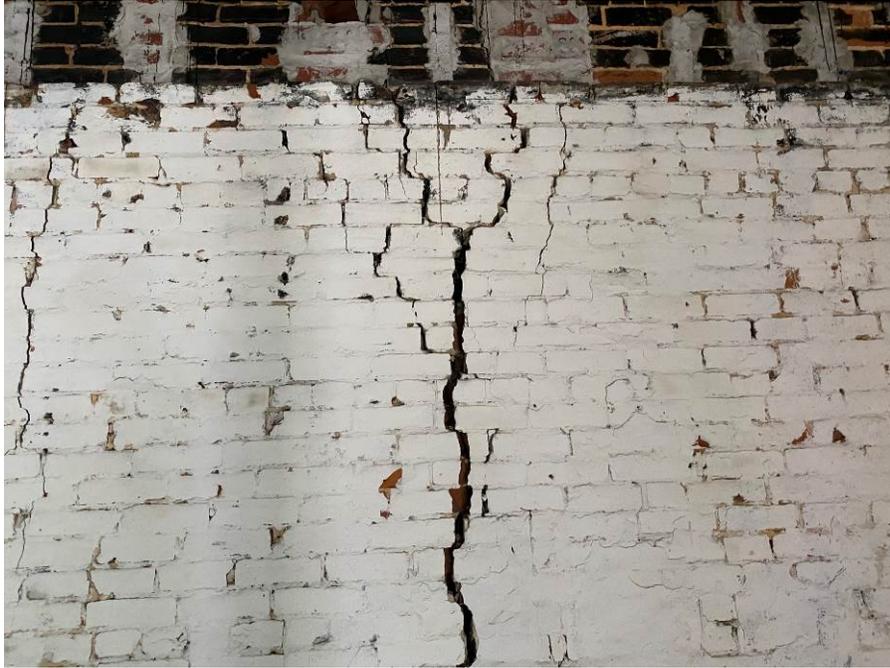
approximately an inch in magnitude and were located on the ground floor and the second story northern exterior wall. The cracks were generally vertical in orientation and traveled through both the brick and the mortar. The cracking had the appearance of aged cracking and did not appear active; however, we recommend that the cracks be repaired to prevent additional separation of the masonry materials. There does appear to be impact damage from the exterior of the building located adjacent to the parking lot on the north side of the building. We recommend tuck pointing the exterior cracks to prevent water infiltration into the building and to prevent additional movement of the bearing wall (Photos 41 through 48)

Photo 43 Crack on North Exterior Wall of 88 North Main

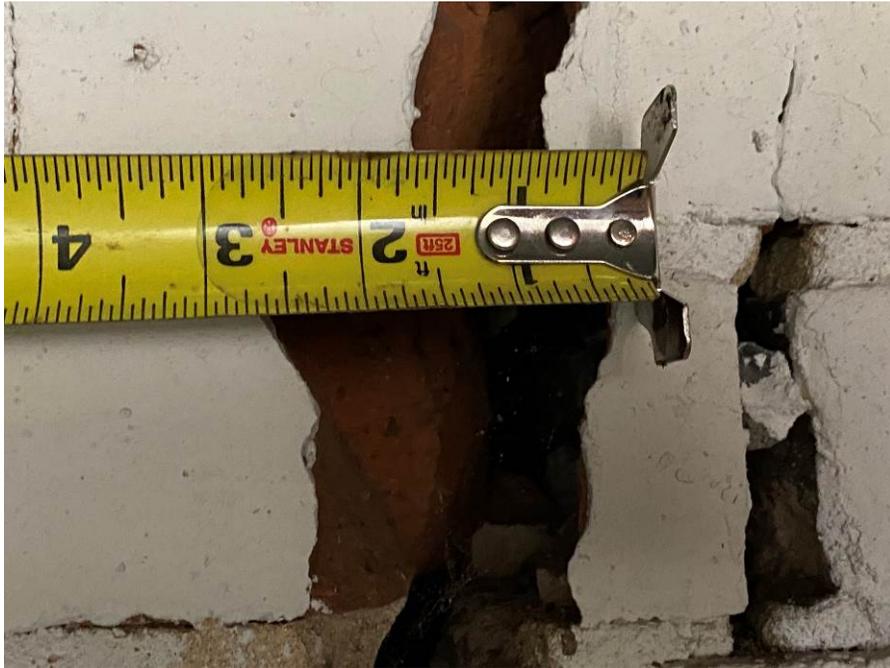
Photo 45 Magnitude of Crack on 88 North Main

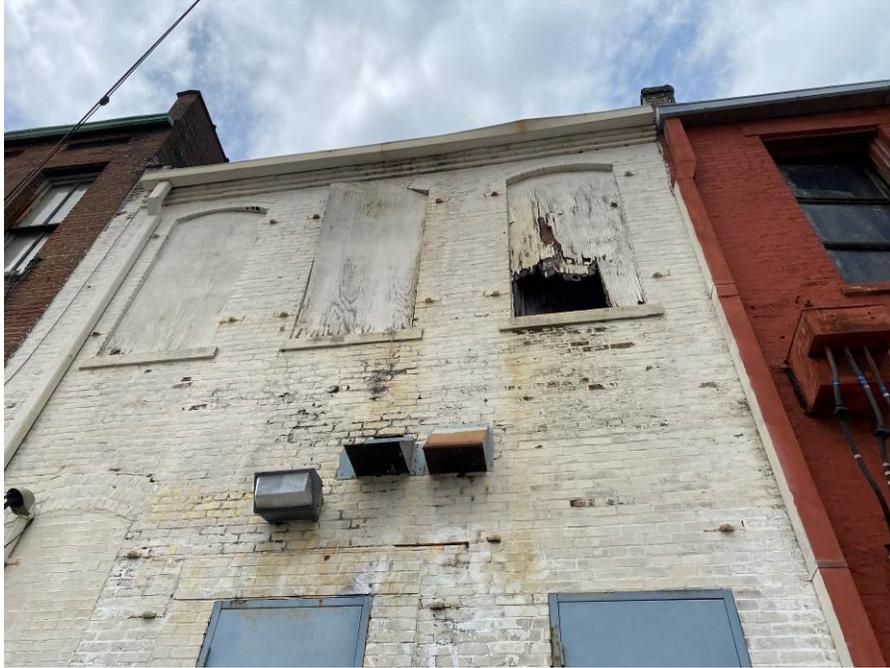
Photo 47 General Condition of Exterior Masonry on Rear of 86 North Main

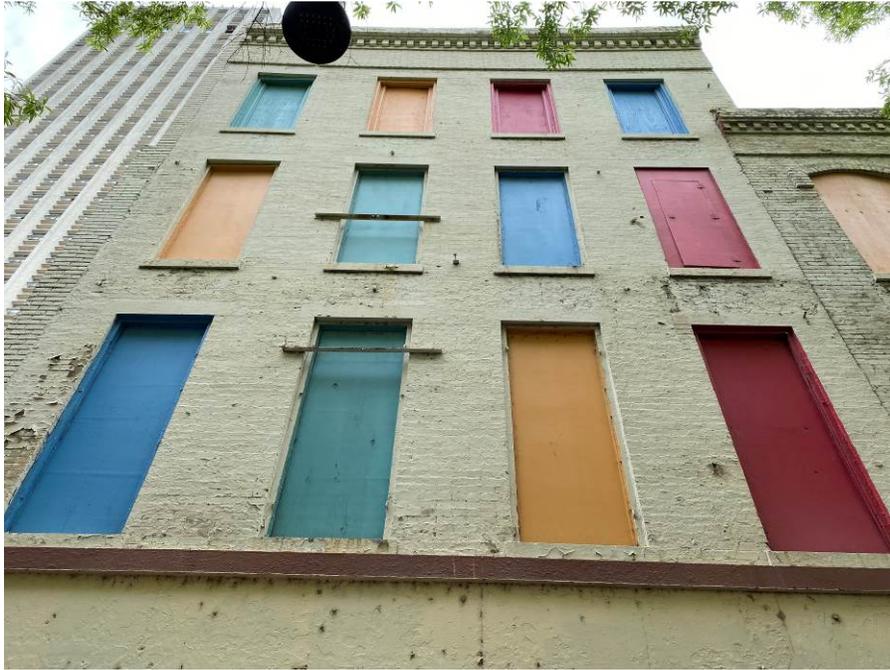
- The remaining unreinforced masonry bearing walls were observed to be in good condition without cracking or settling. The exterior mortar joints were generally in good condition; however, we recommend that some areas will require spot tuck pointing where loss of mortar has occurred. We estimate that tuck pointing will be required on approximately 20 percent of the building exterior. The lintels over the openings were generally in good condition with only minor repairs needed (Photos 49 through 54)

Photo 49 Masonry Condition on 88 North Main Elevation

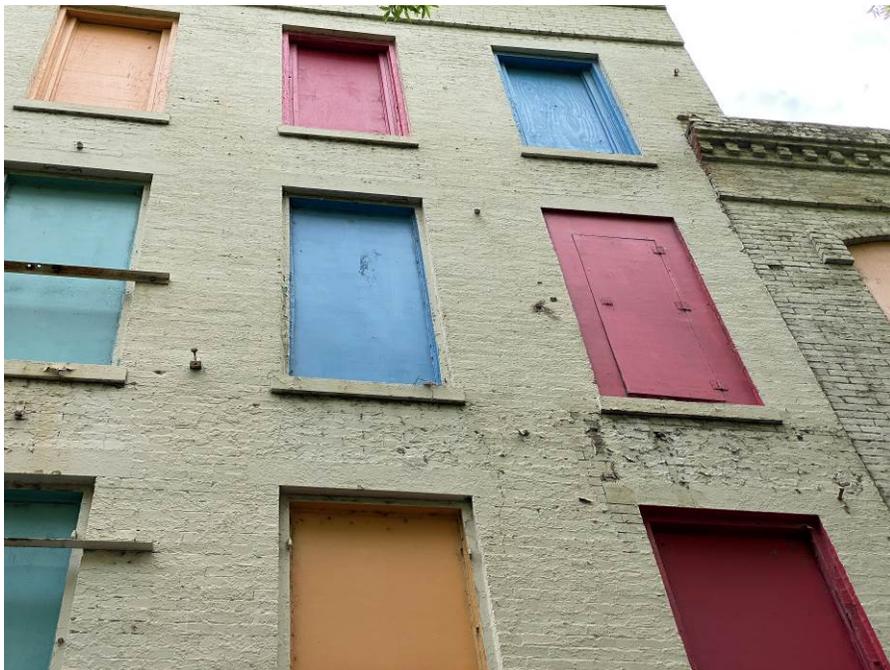
Photo 50 Condition of Exterior Masonry on 88 North Main

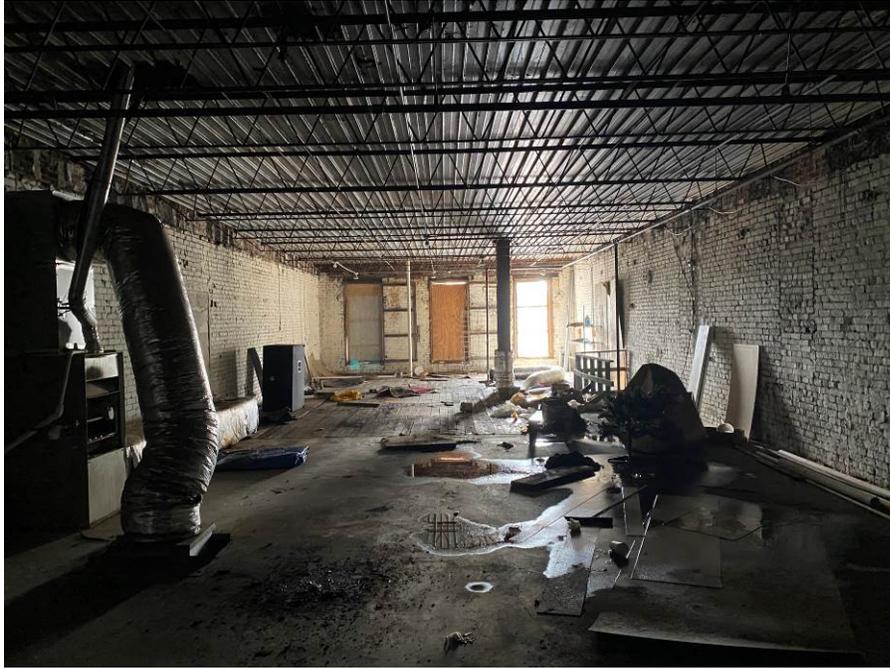
locations shall be completed prior to access to the building to the public. (Photos 55 through 58)

Photo 55 Open Windows at Second Floor 88 North Main

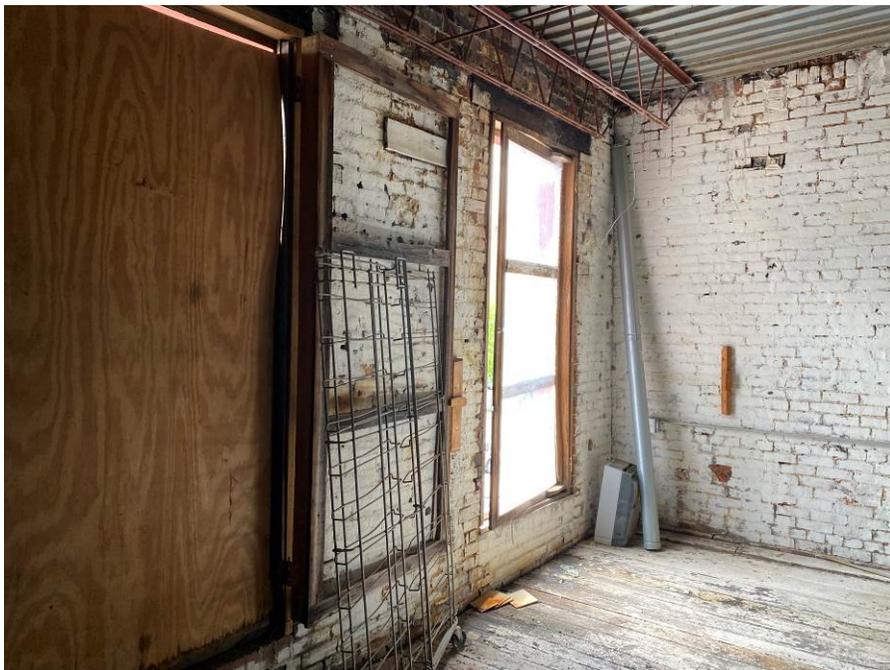
Photo 56 Open Exterior Windows and Openings at 88 North Main

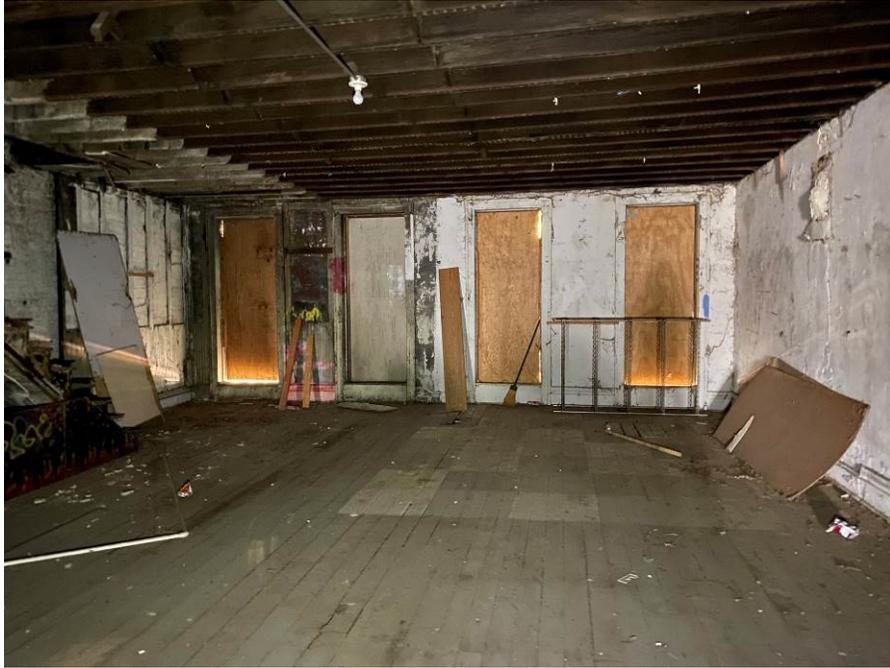
Photo 57 Condition of Window Openings

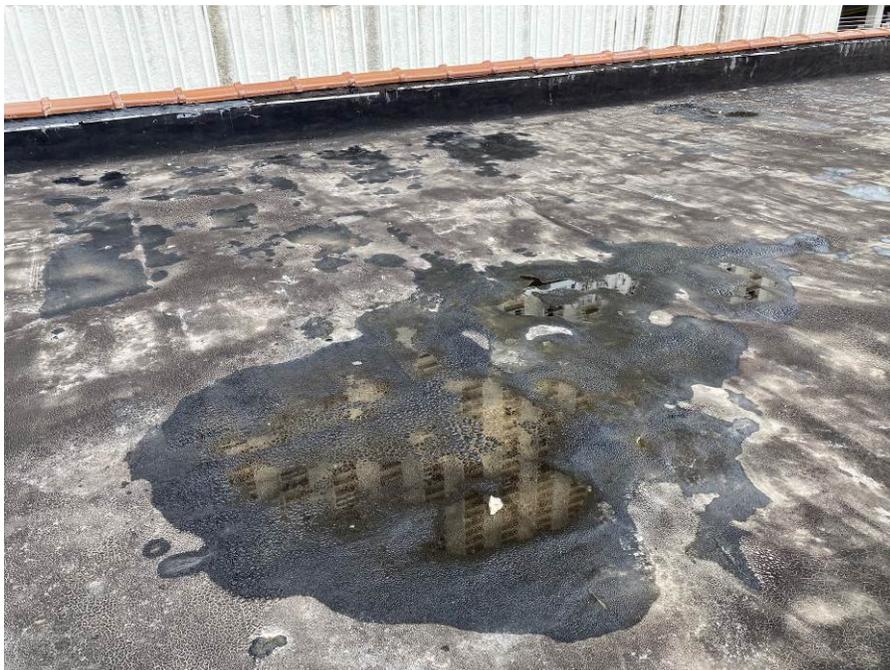
Photo 62 Ponding on Roof Coverings

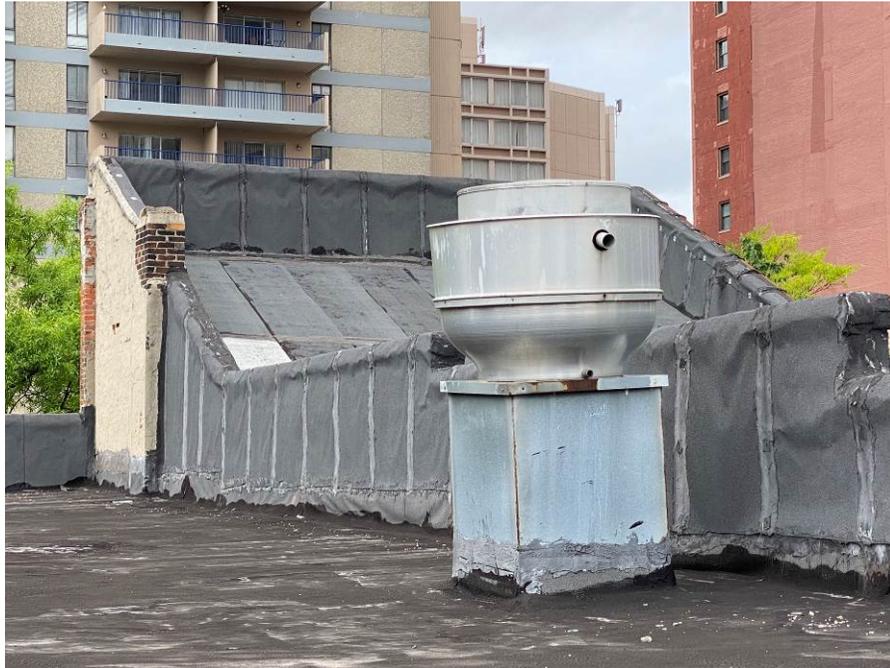
Photo 65 Four Story Roof Area with Aged Roof Coverings on 88 North Main

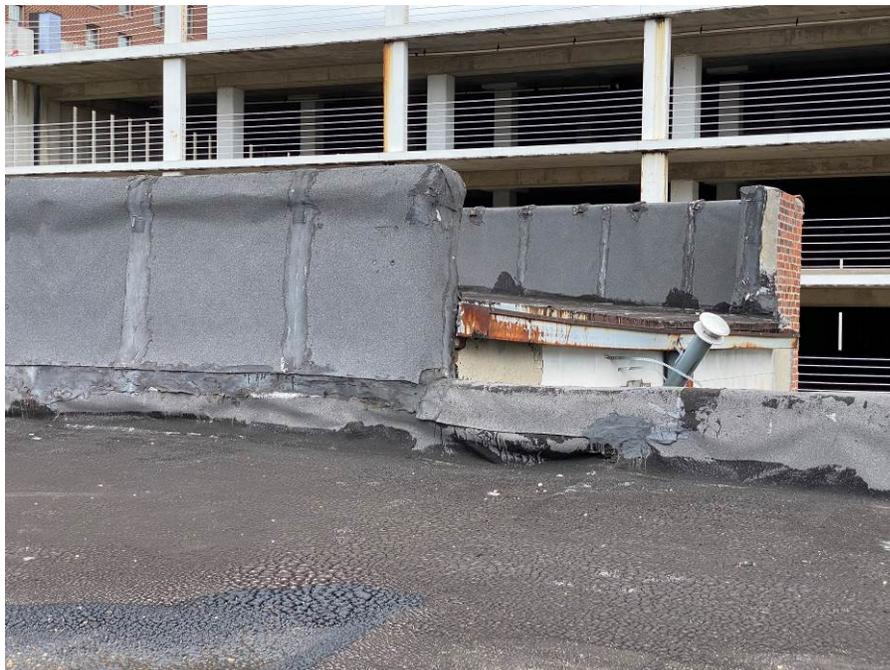
Photo 66 Parapet Wall with Aged Wall Flashing with Gaps and Openings

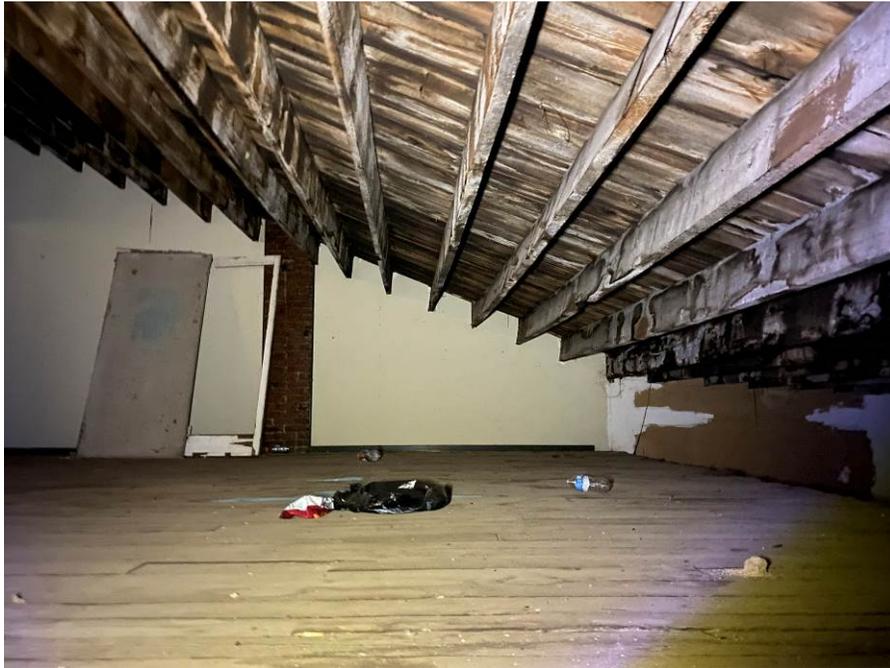
Photo 69 General Condition of the Roof Framing at the Fourth Story Area on 88 N Main

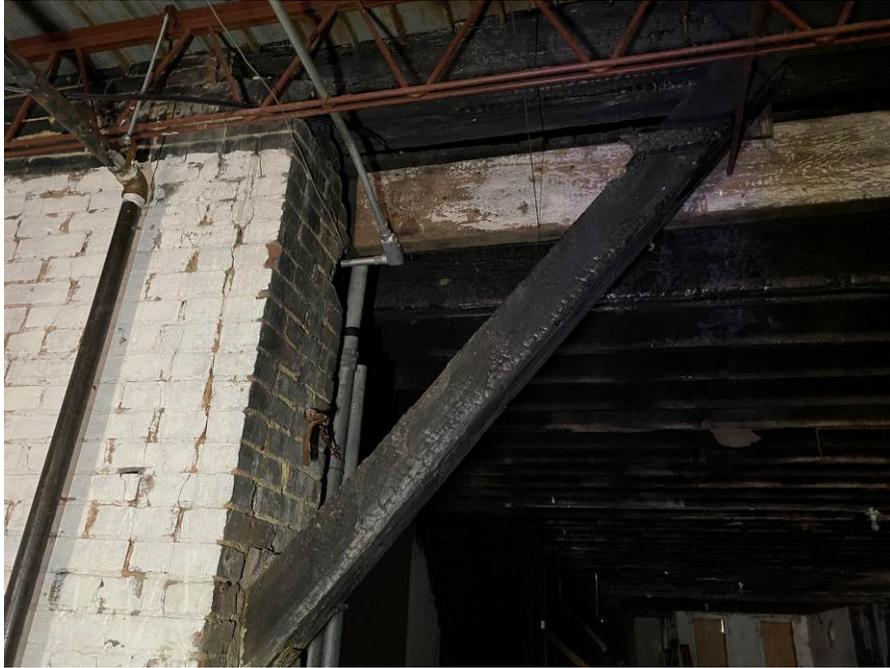
Photo 75 Charred Kicker to be Replaced on 88 North Main

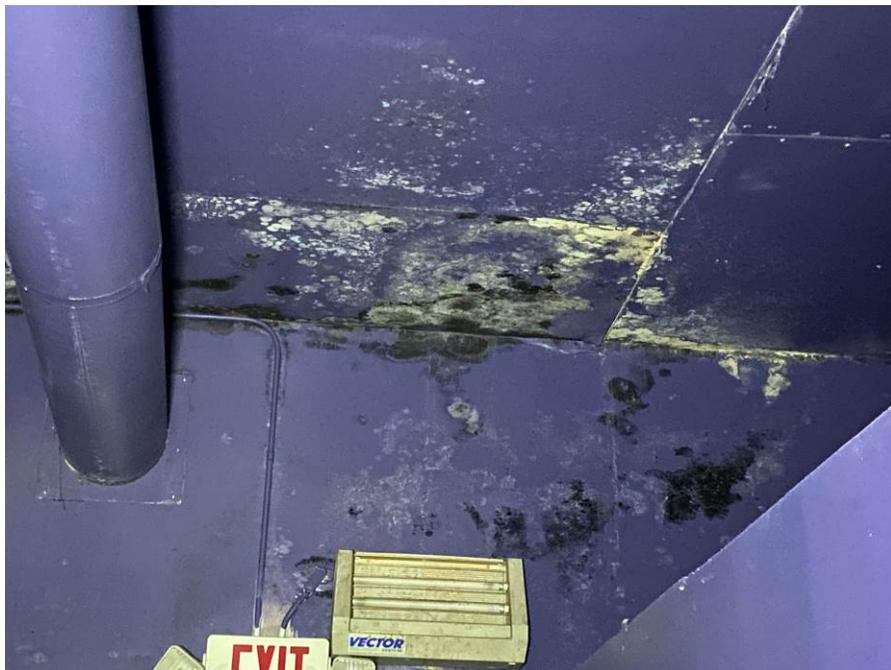
- Water entry has been occurring on 86 North Main at the rear entry. We noted water damages caused by roof covering openings that have damaged the wood framing at the rear of the building. The 1x wood decking had stains consistent with long term water exposure. We recommend removal and replacement of the damaged decking and sistering of the deteriorated wood joists at the rear of the building. (Photos 77 through 88)

Photo 78 Microbial Growth on Interior Finishes on 86 North Main

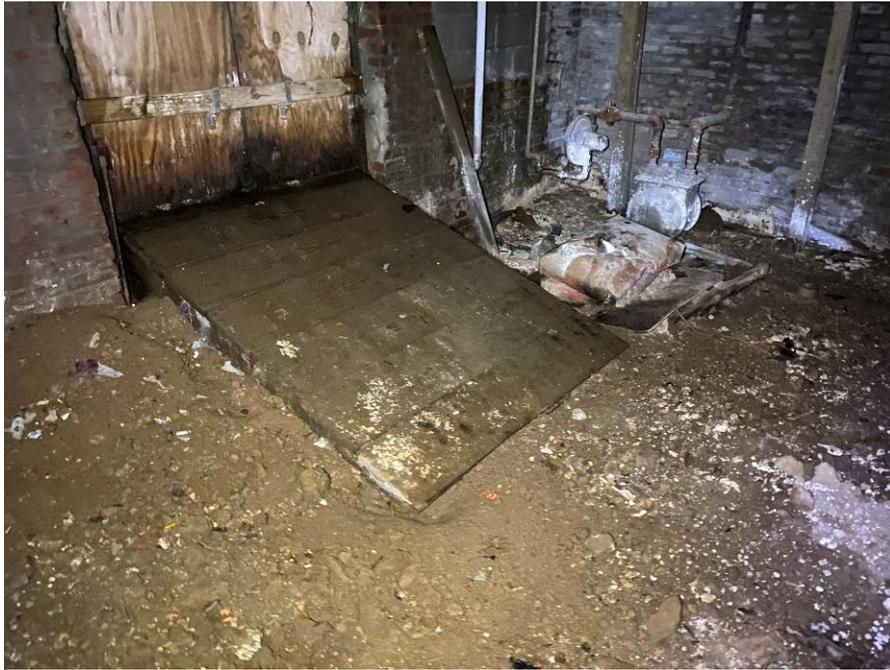
Photo 79 Water Entry into 86 North Main Basement

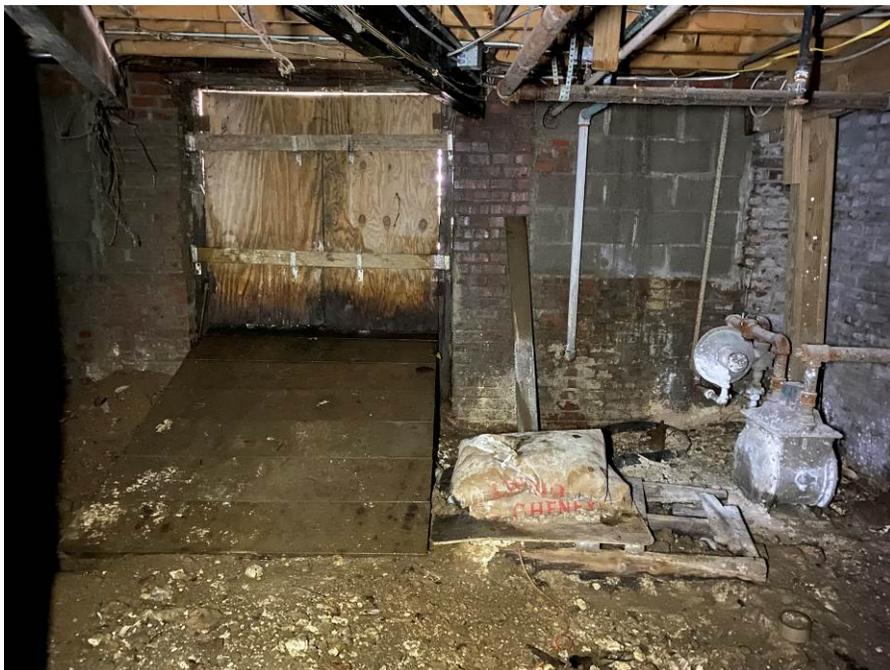
Photo 80 Water Entry into the Basement of 86 North Main

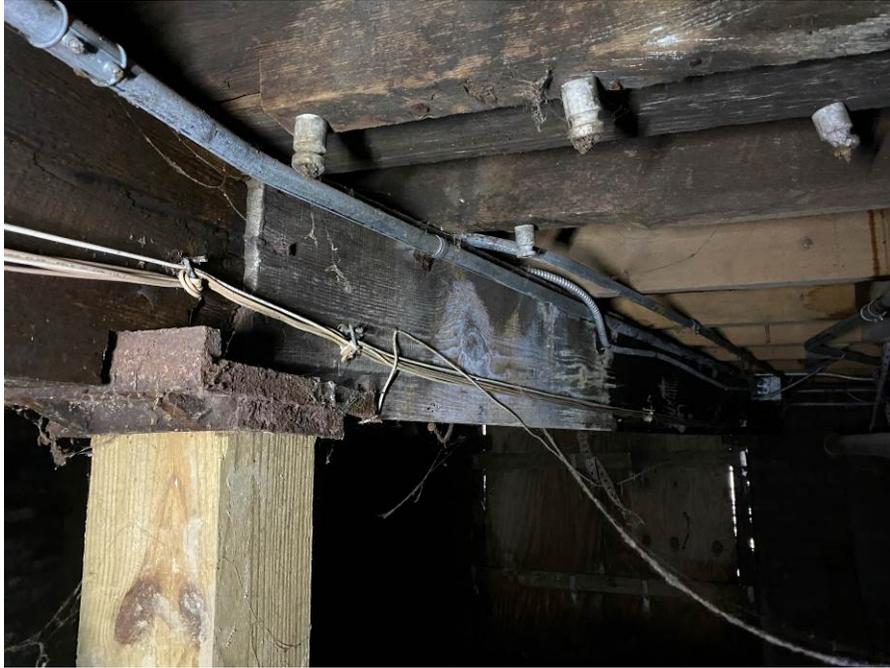
Photo 81 Moisture Stains on Framing in Basement of 86 North Main

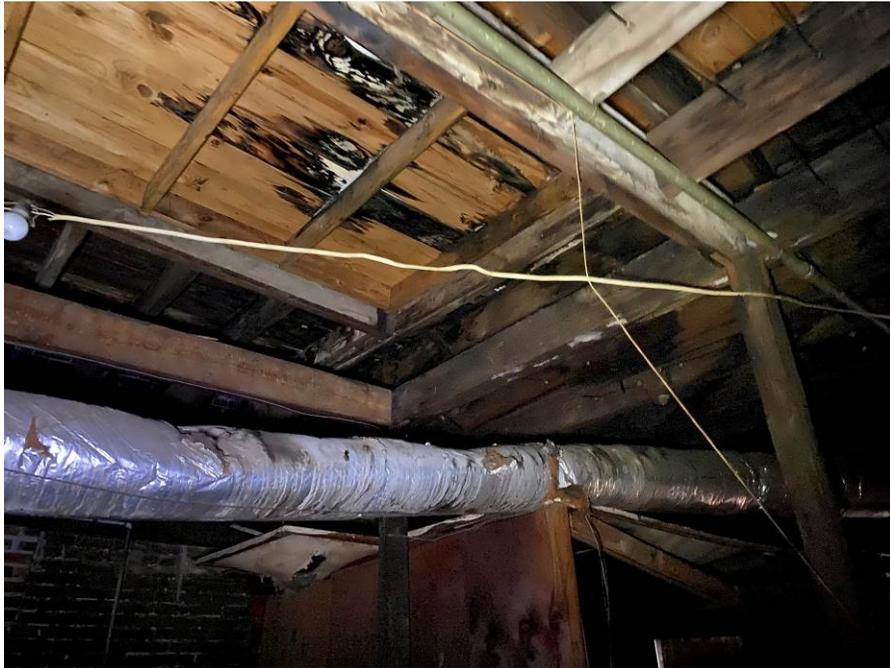
Photo 85 Roof Decking Moisture Damages on 86 North Main

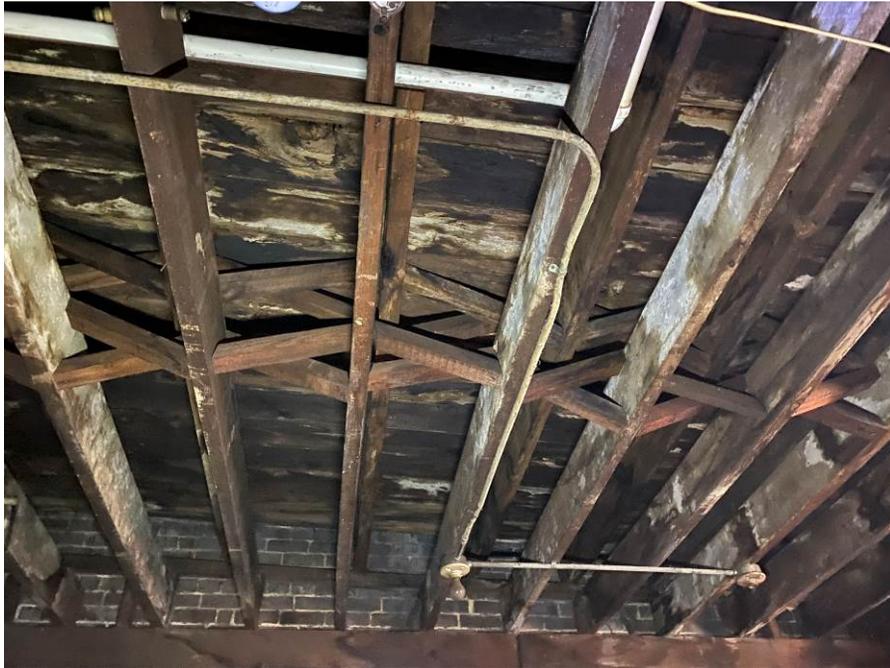
Photo 87 Moisture Exposure to Decking and Framing at Roof at 86 North Main

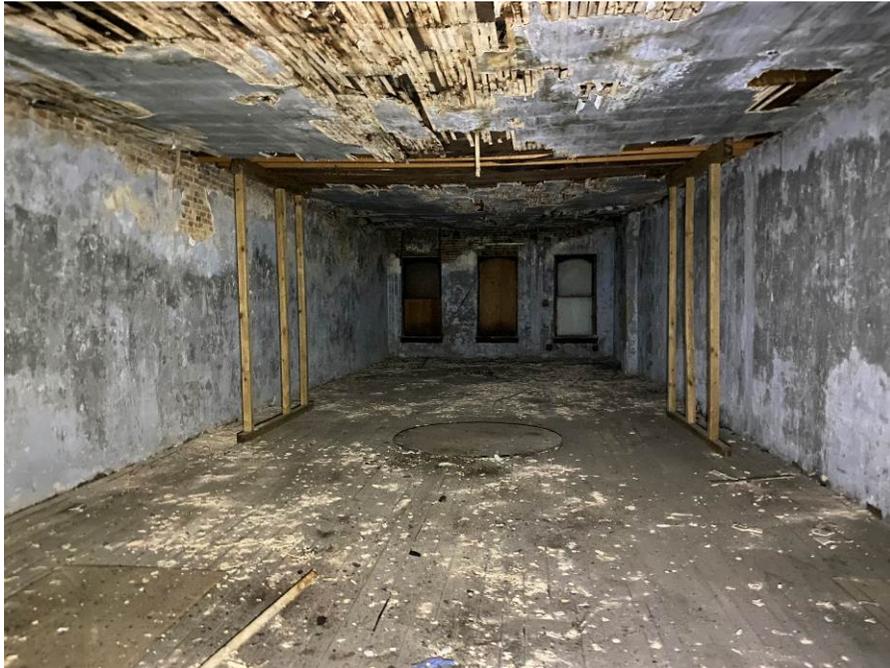
- We observed four (4) roof joists on 86 North Main that were deflecting and had failed. There was temporary shoring in place; however, the shoring was poorly installed and should be strengthened to prevent additional deflection of the roof joists. We observed ponding over the roof coverings on the 86 North Main building that we contributing to the deflection of the roof members. We recommend the upper part of the roof not be accessed by the public until the deflecting joists be repaired. The current repairs do not adequately bear at the masonry walls. The new joists will need to bear at the masonry bearing walls on each side of the building. (Photos 89 through 100)

Photo 89 Shoring at Roof of 86 North Main

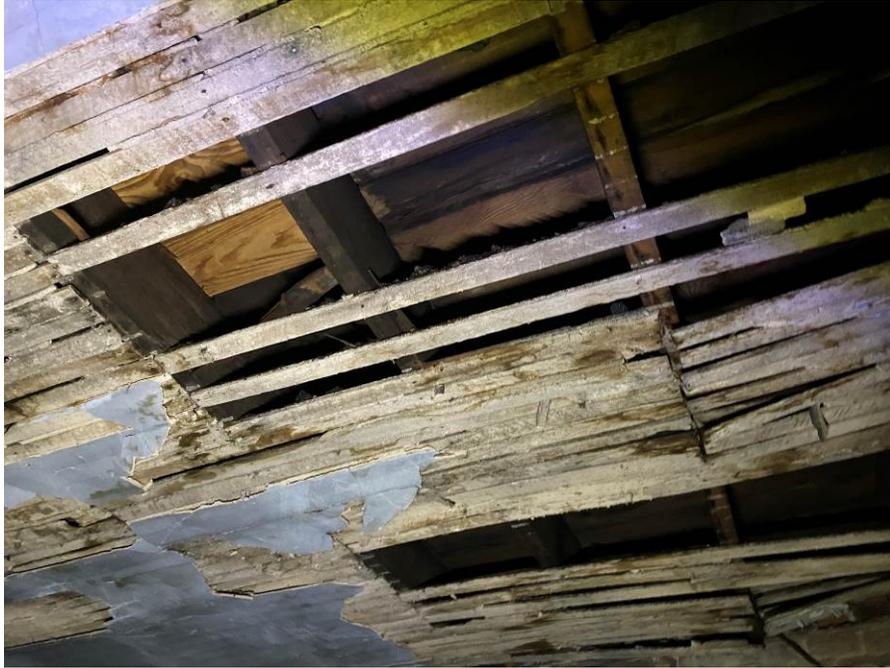
Photo 91 Moisture Damages at 86 North Main Roof to be Repaired

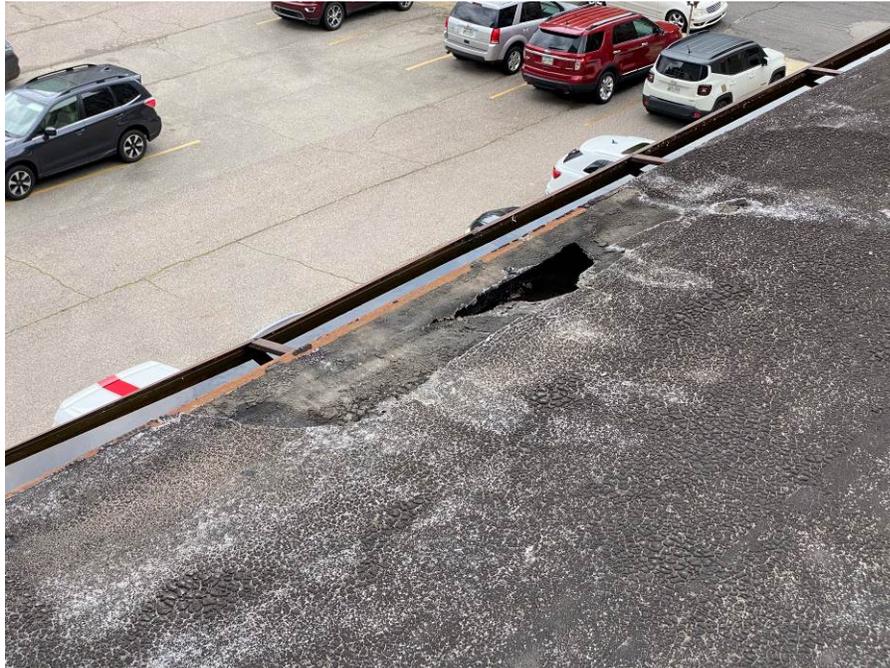
Photo 93 Hole in Roof Coverings on 86 North Main Causing Damages Below

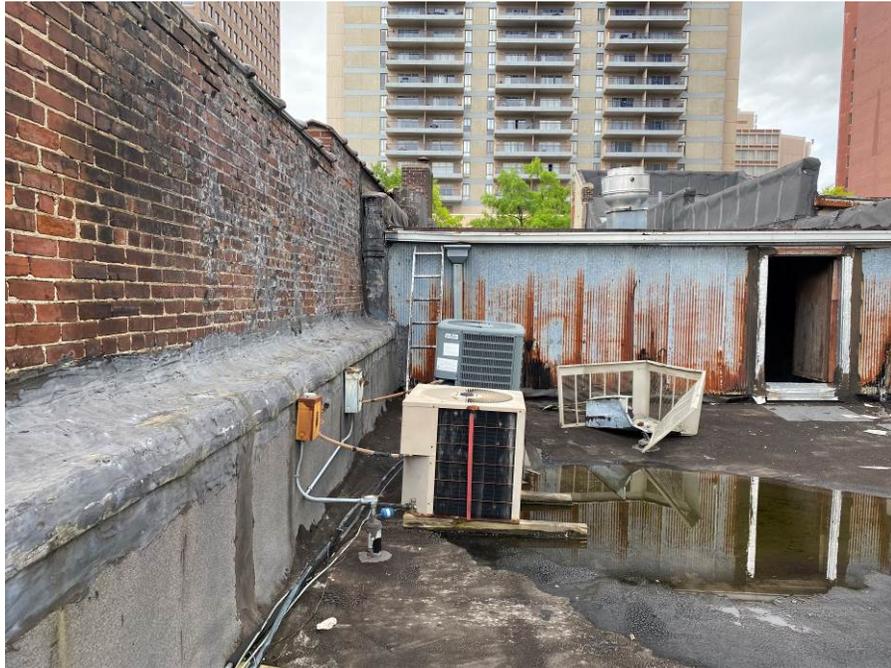
Photo 95 Aged Roof Flashing at Roof Coverings

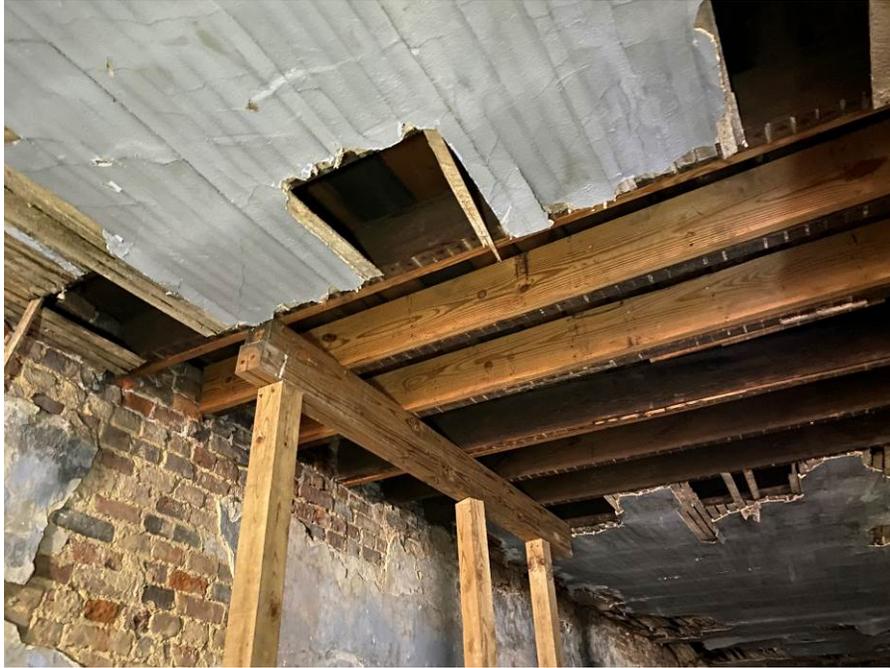
Photo 97 Condition of Existing Shoring at Roof of 86 North Main (Repairs Required)

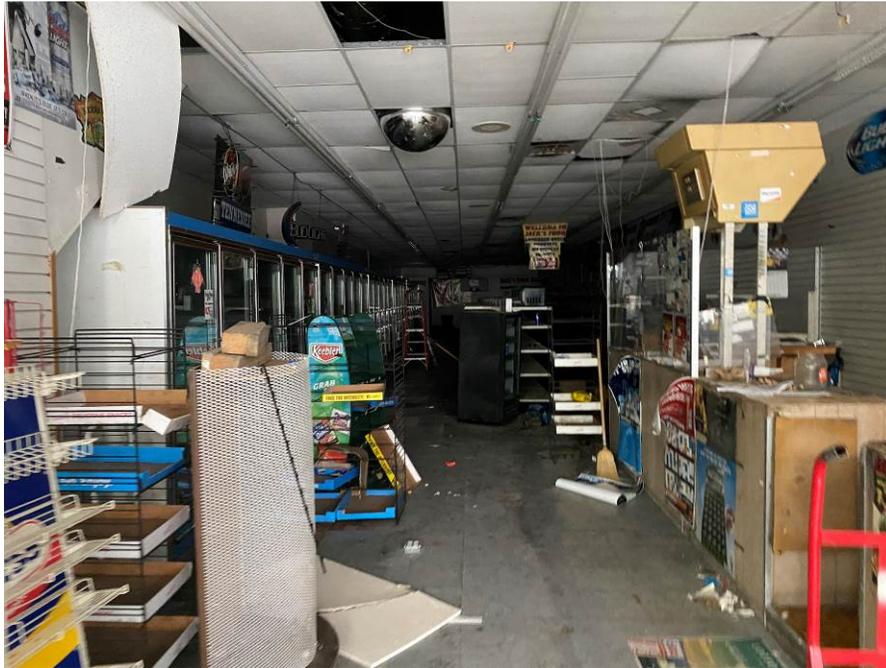
- Several locations were observed on the upper floor of the 84 North Main building that showed areas around the perimeter where staining had occurred consistent with long term water entry through the roof. The majority of the structure was covered up by finishes; however, the areas were generally small and did not appear to have been widespread. We recommend that additional exploration of the structure be performed in covered up areas to determine full extend of damages from water exposure. In our professional opinion, the damages were minor enough to allow full entry into 84 North Main. (Photos 101 through 108)

Photo 101 Interior Water Stains to Acoustical Ceiling Tiles at 84 North Main

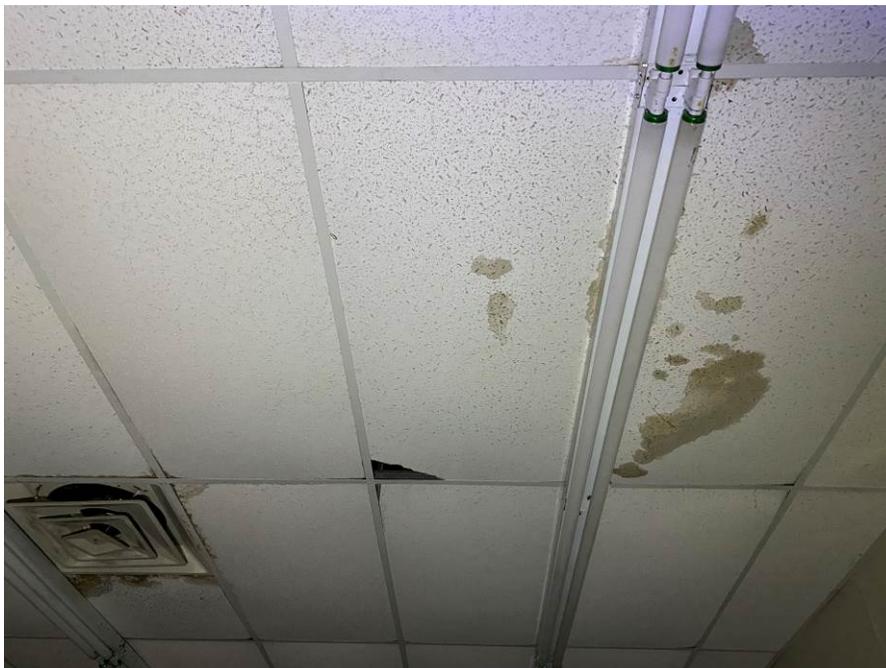
Photo 102 Acoustical Ceiling Tile Water Stains at 84 North Main

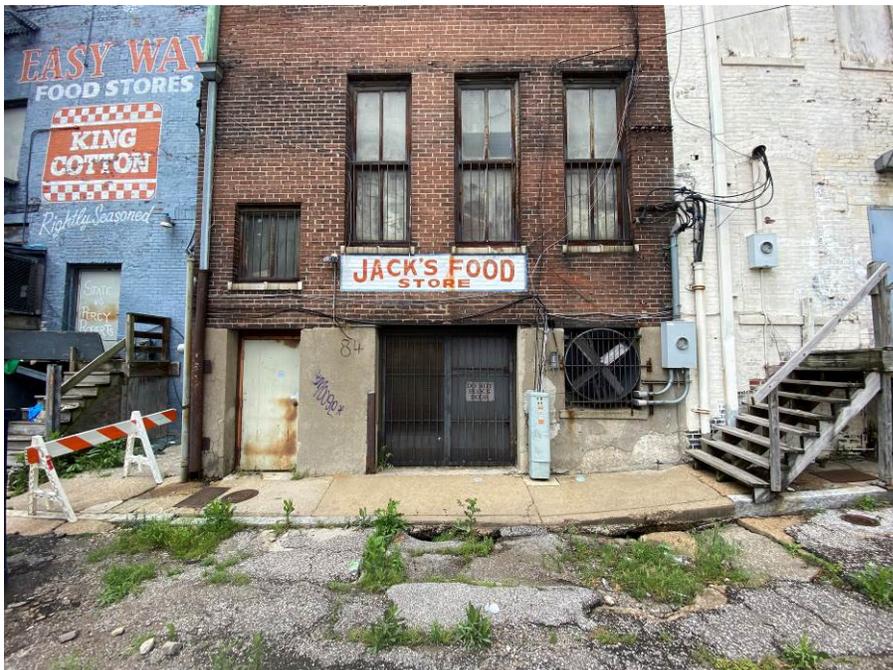
settling at the time of observation; however, we recommend regular observation of this area until repairs have been completed. (Photos 109 through 110)

Photo 110 Collapsing Sidewalk and Pavement Outside 84 North Main

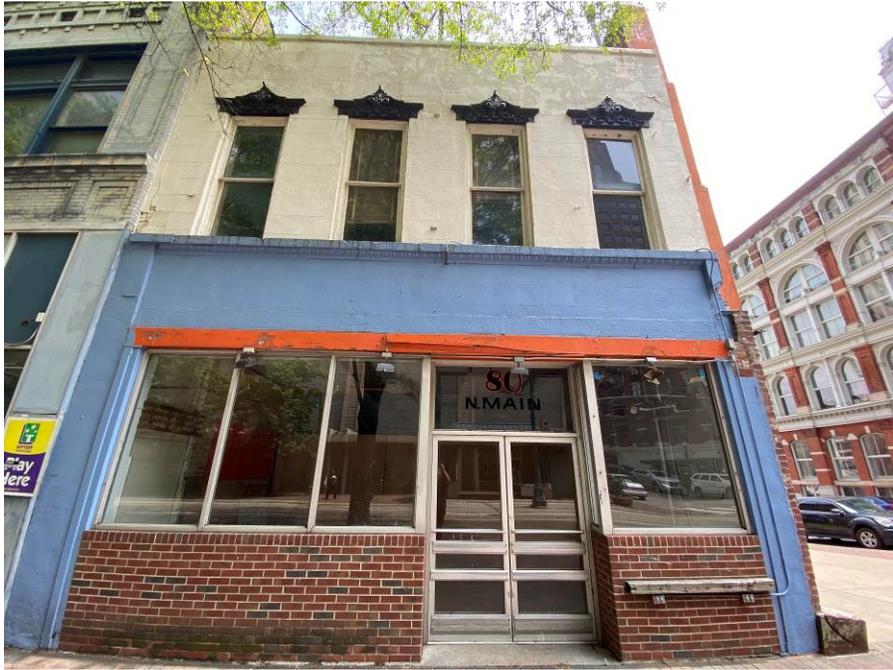
- We noted some exterior façade cracking on the scratch coating of the west façade of 80 North Main at the second floor. The cracking was not observed in the masonry from the inside and did not appear to be in the masonry exterior wall but just surface cracking through the coating. (Photos 111 through 116)

Photo 111 Exterior Condition of 80 North Main

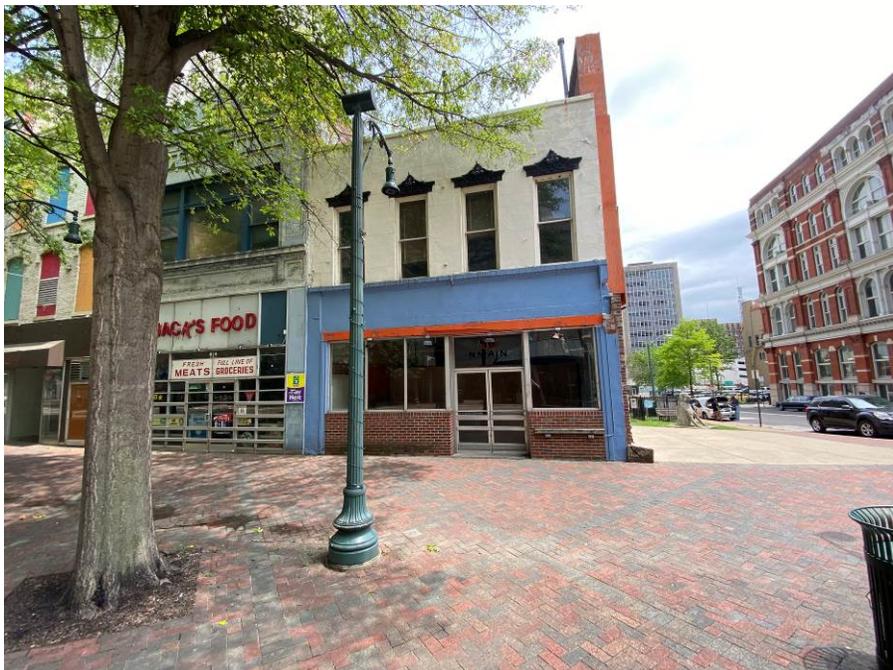
Photo 112 Masonry of 80 North Main
